Bell Run - South Fork Licking River HUC-12 (05040006 0406)

Nine-Element Nonpoint Source Implementation Strategic Plan (NPS-IS Plan)

December 2021

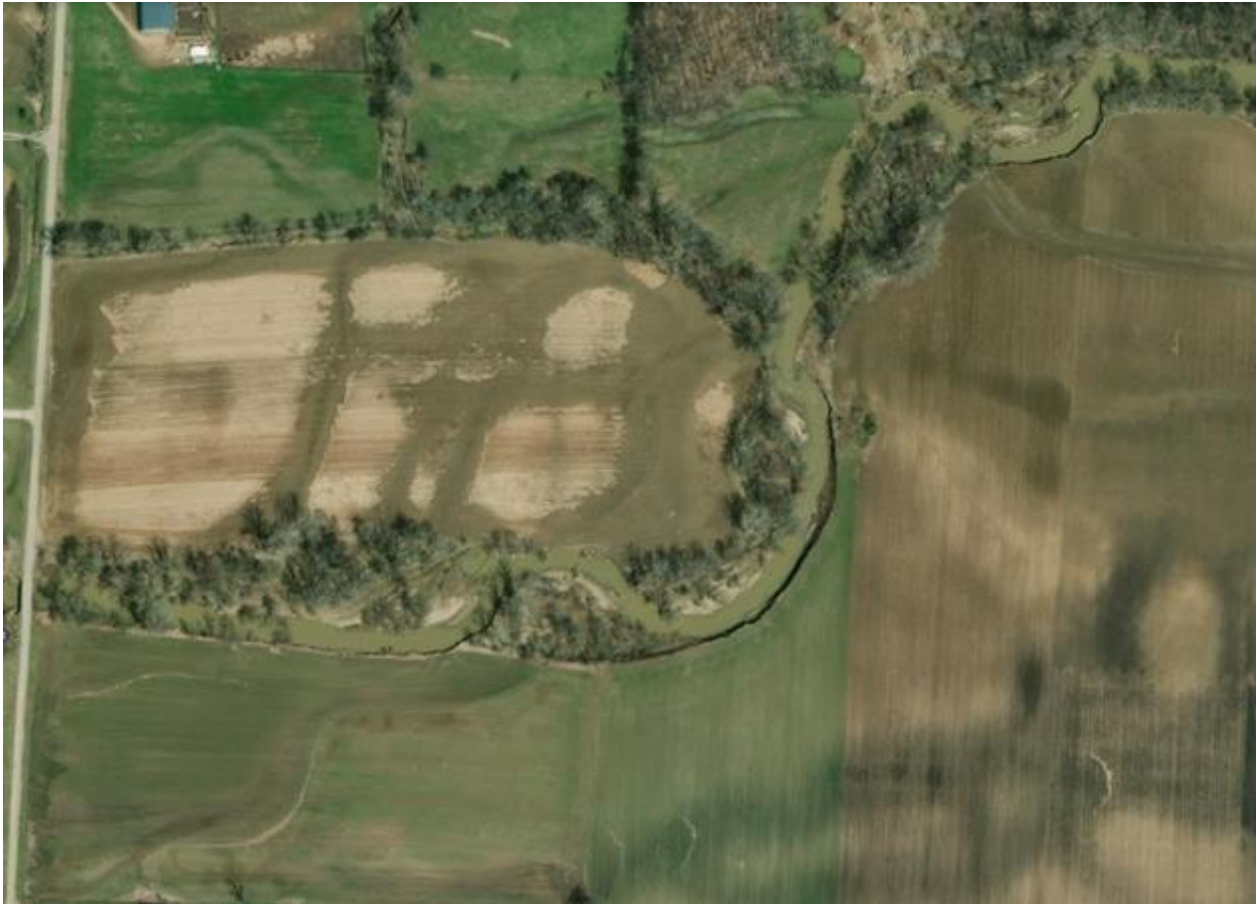
Figure 11. Example of South Fork Licking River varying stream riparian corridor

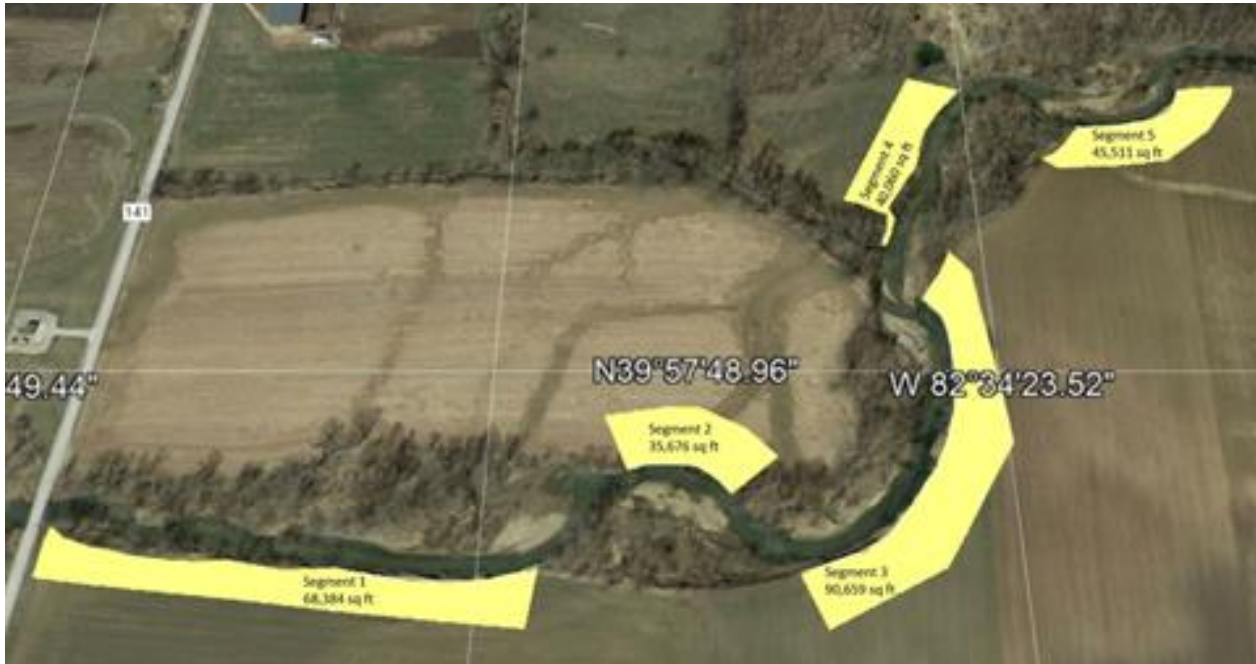
Project #2: Site RM 21.2 to 20.6., total length 2,818 ft

Figure 18. Site: RM 21.2 to 20.6 of critical area 1 within the Bell Run – SFLR HUC-12.

Table 13. Site: RM 21.2 to 20.6 of critical area 1 within the Bell Run – SFLR HUC-12. An asterisk (*) in the 'Buffer Length' column signifies a riparian corridor planting project coupled with a stream restoration or area where a natural channel design is needed.

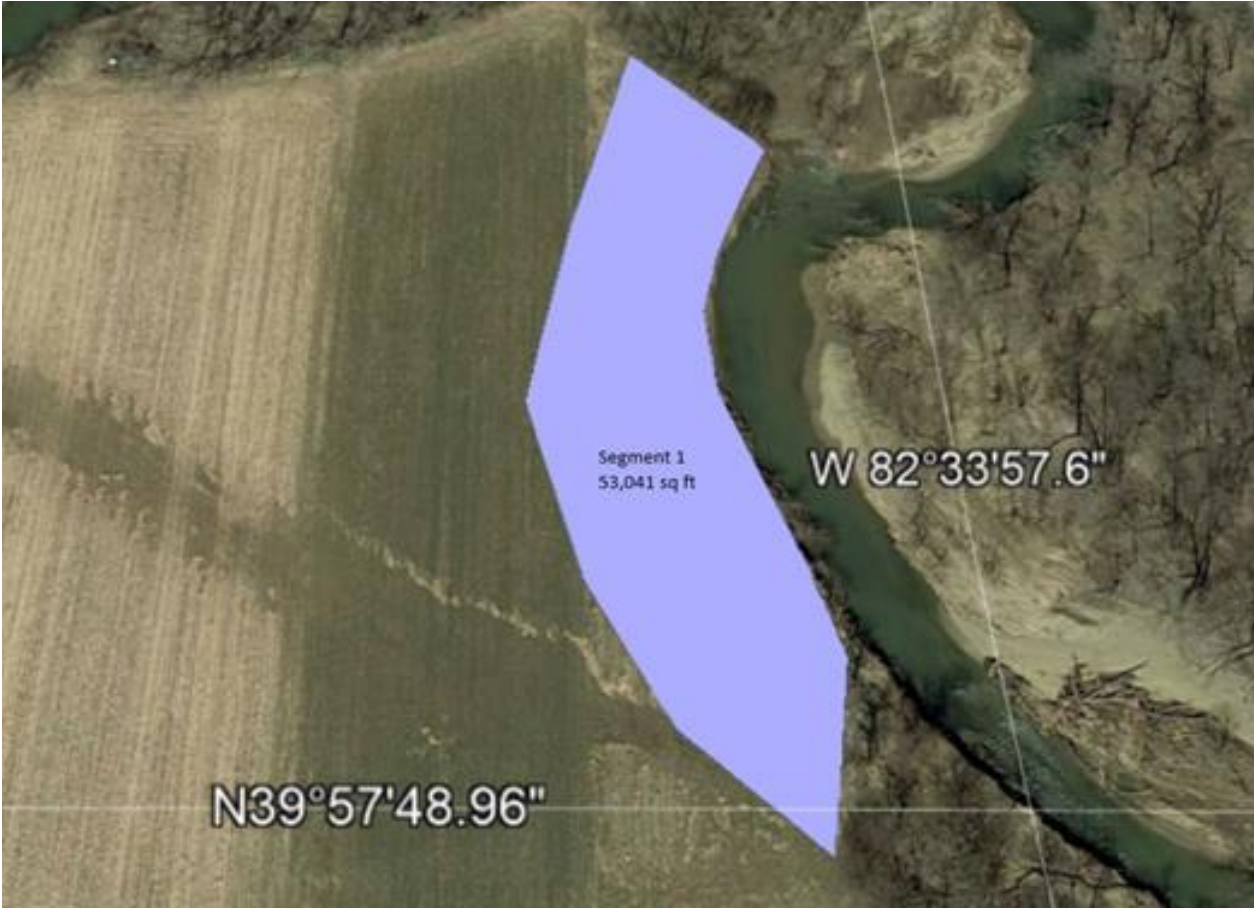
Project #3: Site RM 20.15 to 20.25, total length 427 ft

Figure 19. Site: RM 20.15 to 20.25 of critical area 1 within the Bell Run – SFLR HUC-12.

Table 14. Site: RM 20.15 to 20.25 of critical area 1 within the Bell Run – SFLR HUC-12. An asterisk (*) in the 'Buffer Length' column signifies a riparian corridor planting project coupled with a stream restoration or area where a natural channel design is needed.

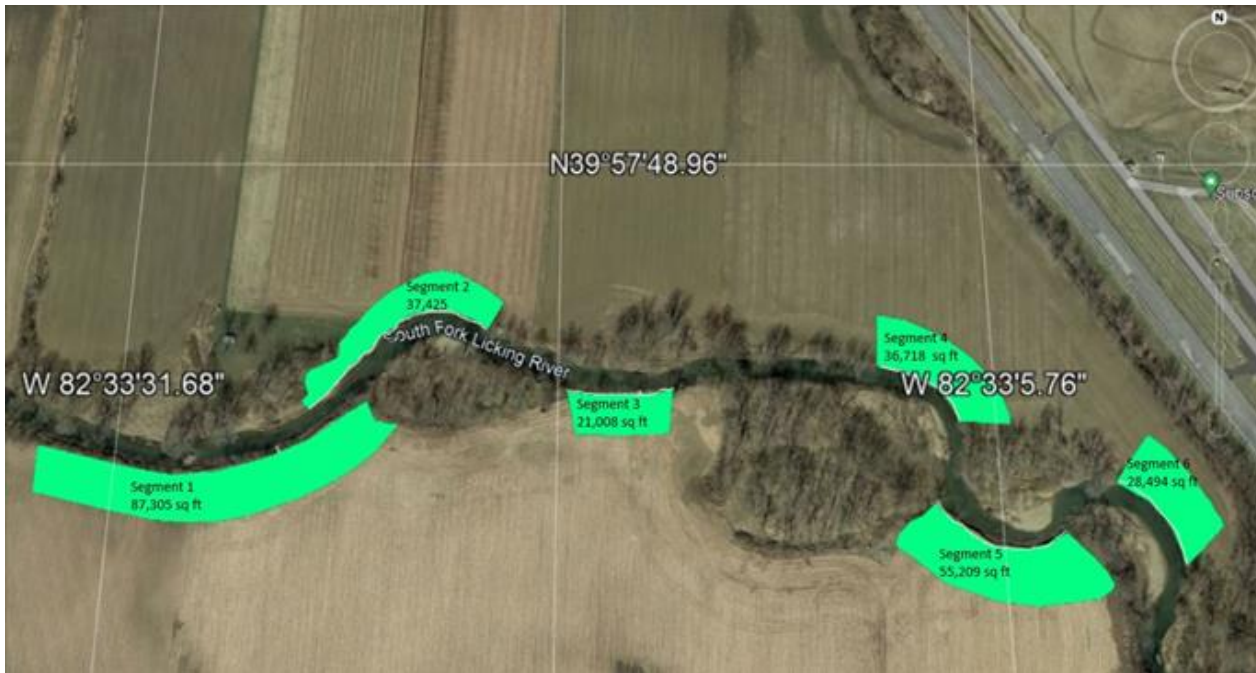
Project #4: Site RM 19.80 to 19.20, total length 2,571 ft

Figure 20. Site: RM 19.80 to 19.20 of critical area 1 within the Bell Run – SFLR HUC-12.

Table 15. Site: RM 19.80 to 19.20 of critical area 1 within the Bell Run – SFLR HUC-12.

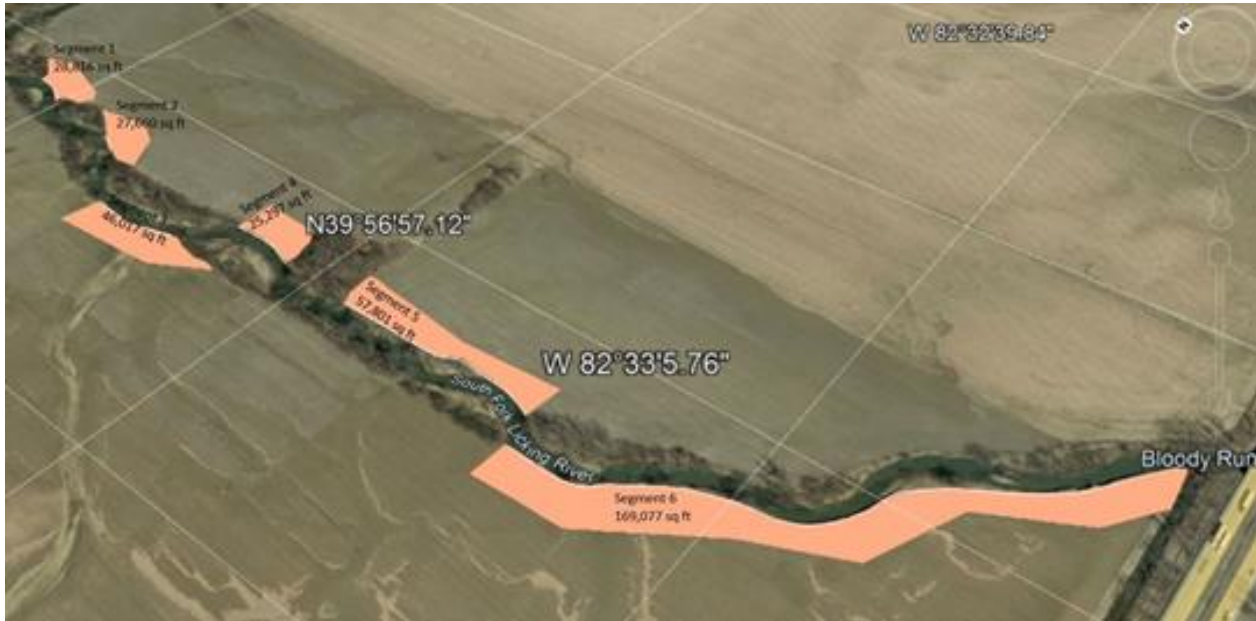
Project #5: Site RM 18.95 to 17.85, total length 3,850 ft

Figure 21. Site: RM 18.95 to 17.85 of critical area 1 within the Bell Run – SFLR HUC-12.

Table 16. Site: RM 18.95 to 17.85 of critical area 1 within the Bell Run – SFLR HUC-12. An asterisk (*) in the 'Buffer Length' column signifies a riparian corridor planting project coupled with a stream restoration or area where a natural channel design is needed.

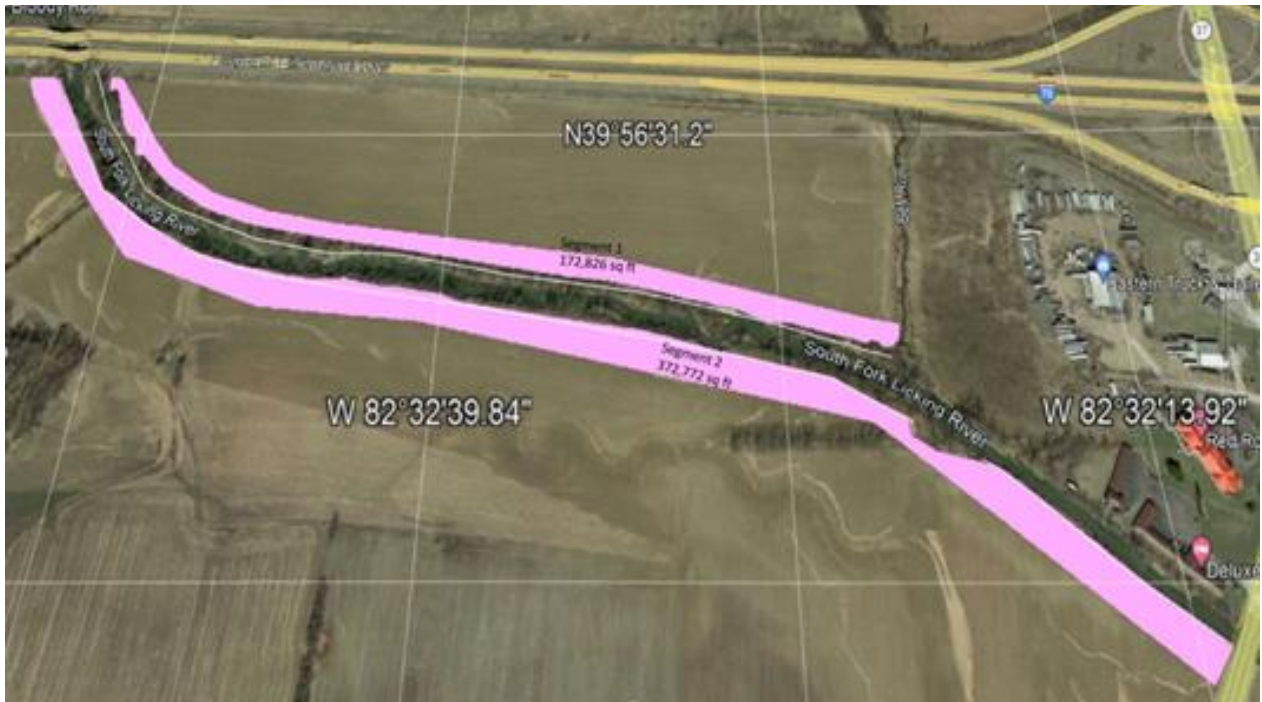
Project #6: Site RM 17.80 to 17.05, total length 6,019 ft

Figure 22. Site: RM 17.80 to 17.05 of critical area 1 within the Bell Run – SFLR HUC-12.

Table 17. Site: RM 17.80 to 17.05 of critical area 1 within the Bell Run – SFLR HUC-12.

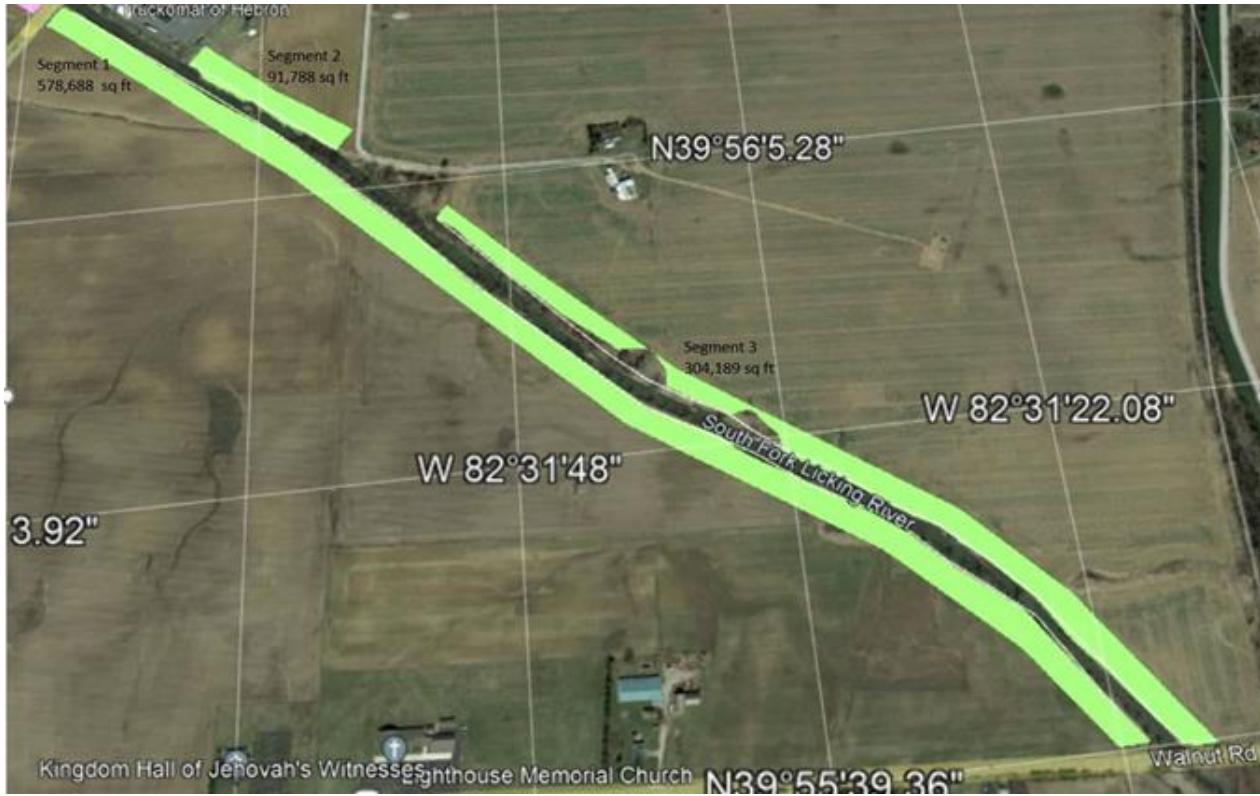
Project #7: Site RM 17.05 to 16.0, total length 10,084 ft

Figure 23. Site RM 17.05 to 16.0 of critical area 1 within the Bell Run - SFLR HUC-12

Table 18. Site: RM 17.05 to 16.0 of critical area 1 within the Bell Run – SFLR HUC-12.

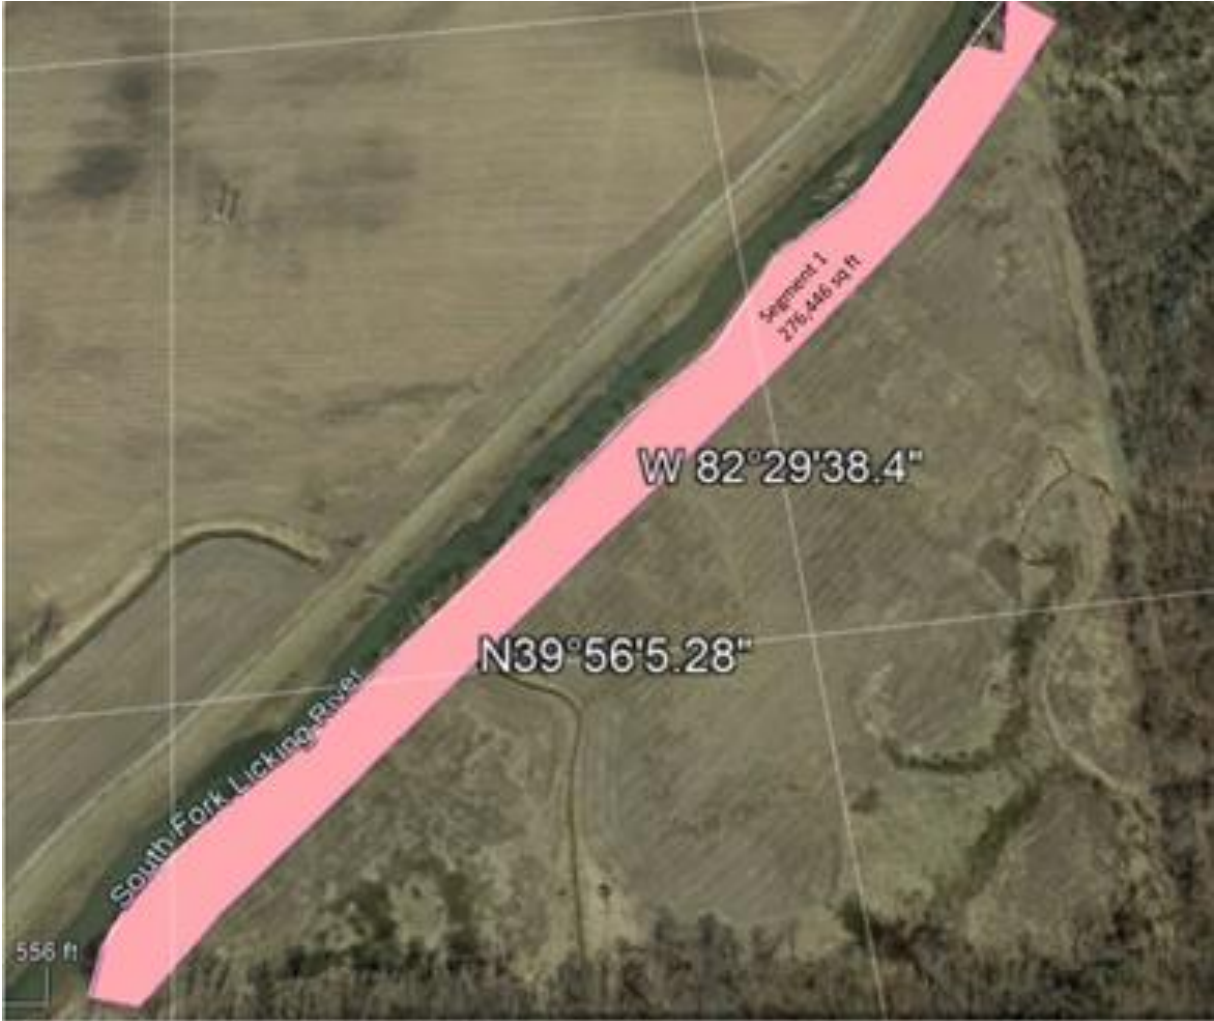
Project #8: Site RM 14.50 to 14.05, total length 2,570 ft

Figure 24. Site: RM 14.50 to 14.05 of critical area 1 within the Bell Run – SFLR HUC-12

Table 19. Site: RM 14.50 to 14.05 of critical area 1 within the Bell Run – SFLR HUC-12.

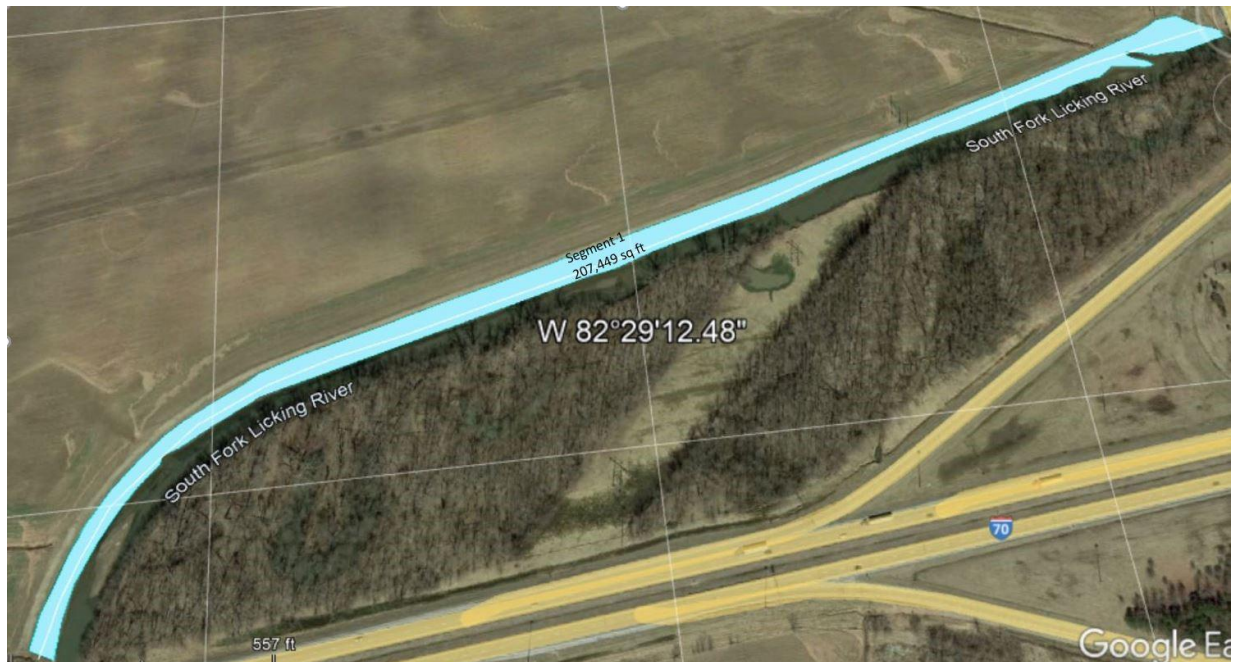
Project #9: Site RM 13.6 to 13.0, total length 3,379 ft

Figure 25. Site: RM 13.6 to 13.0 of critical area 1 within the Bell Run - SFLR HUC-12

Table 20. Site: RM 13.6 to 13.0 of critical area 1 within the Bell Run – SFLR HUC-12.

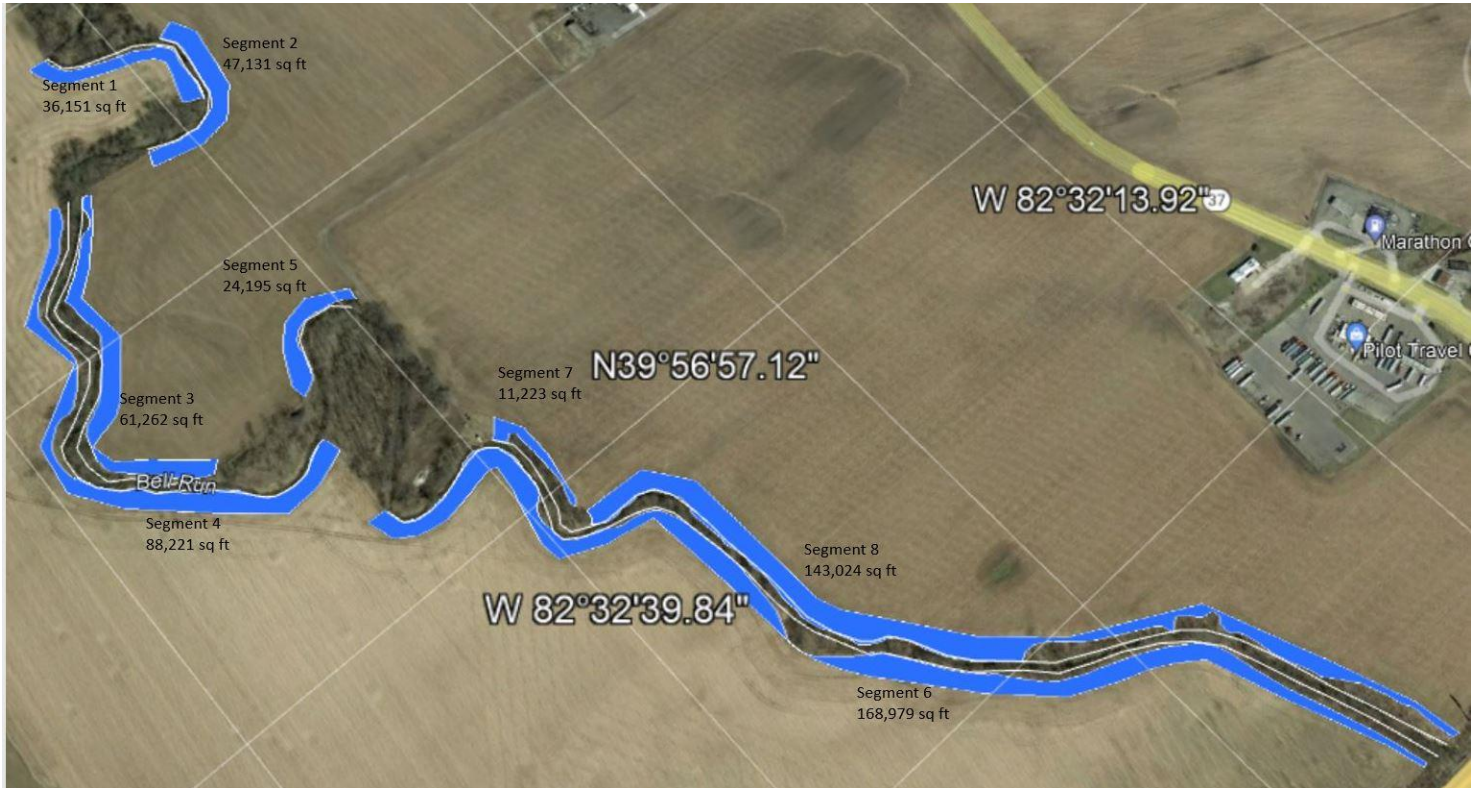
Project #10: Site RM 1.7 to 0.2 total length 7,961 ft

Figure 26. Site: RM 1.7 to 0.2 of critical area 1 within the Bell Run - SFLR HUC-12

Table 21 Site: RM 1.7 to 0.2 of critical area 1 within the Bell Run – SFLR HUC-12.
