SOUTH FORK LICKING RIVER

Flood Damage Reduction Planning Study

Prepared for:

South Licking Watershed Conservancy District

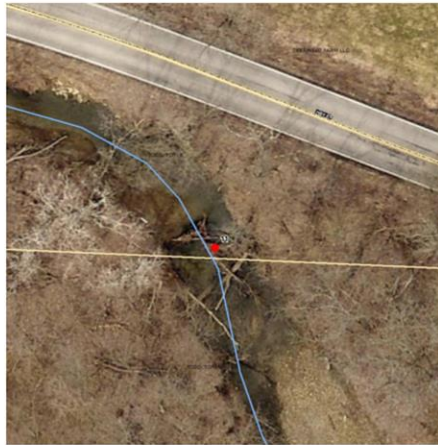
**SLWCD Channel Maintenance
Field Score Card
Site 11**

ID #:	11
Latitude:	40.02107565
Longitude:	-82.53015772
County:	
Stream:	UT to Ramp Creek
Address:	1053 HAYES RD, GRANVILLE, OH
Property Owner:	KSP INFRA USA LLC
Parcel:	071-326400-00.000
Watershed:	Ramp Creek
Floodplain:	A
Logjam Category:	Log Jam Very Large
Drainage Area:	4.22 Square Miles
Last Rain Event:	11/14/2022

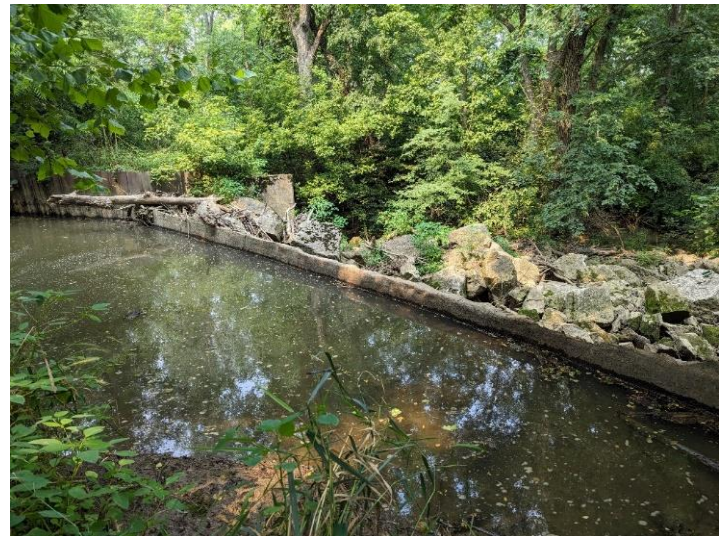
Photo: Looking N.E. at Bloody Run Weir, July 2023
Water was heard and observed leaking through weir below the waterline

The photos below provide more information regarding the Bloody Run weir overflow from the Feeder Canal to Pigeon Swamp Ditch and then to SFLR. The photos from December 2022 represent less than one-inch of rainfall in the upstream watershed and demonstrate that most of the flow in the northern portion of the Feeder Canal all going over the Blood Run weir, and not toward Buckeye Lake. A more recent photo during dry conditions shows the water level below the lip of the weir, but it was observed to be leaking through a hole in the Bloody Run weir structure, which is in very poor condition, and flowing into Pigeon Swamp Ditch.

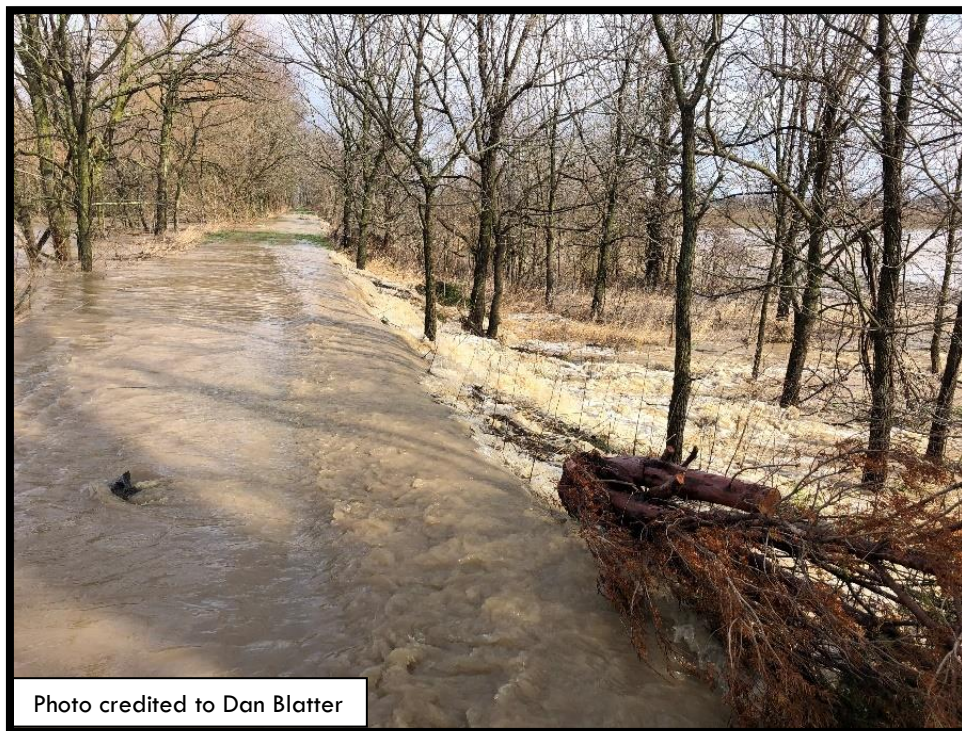
Photo: Looking north along Feeder Canal Embankment just north of Palmer Road during March 2020 flood event

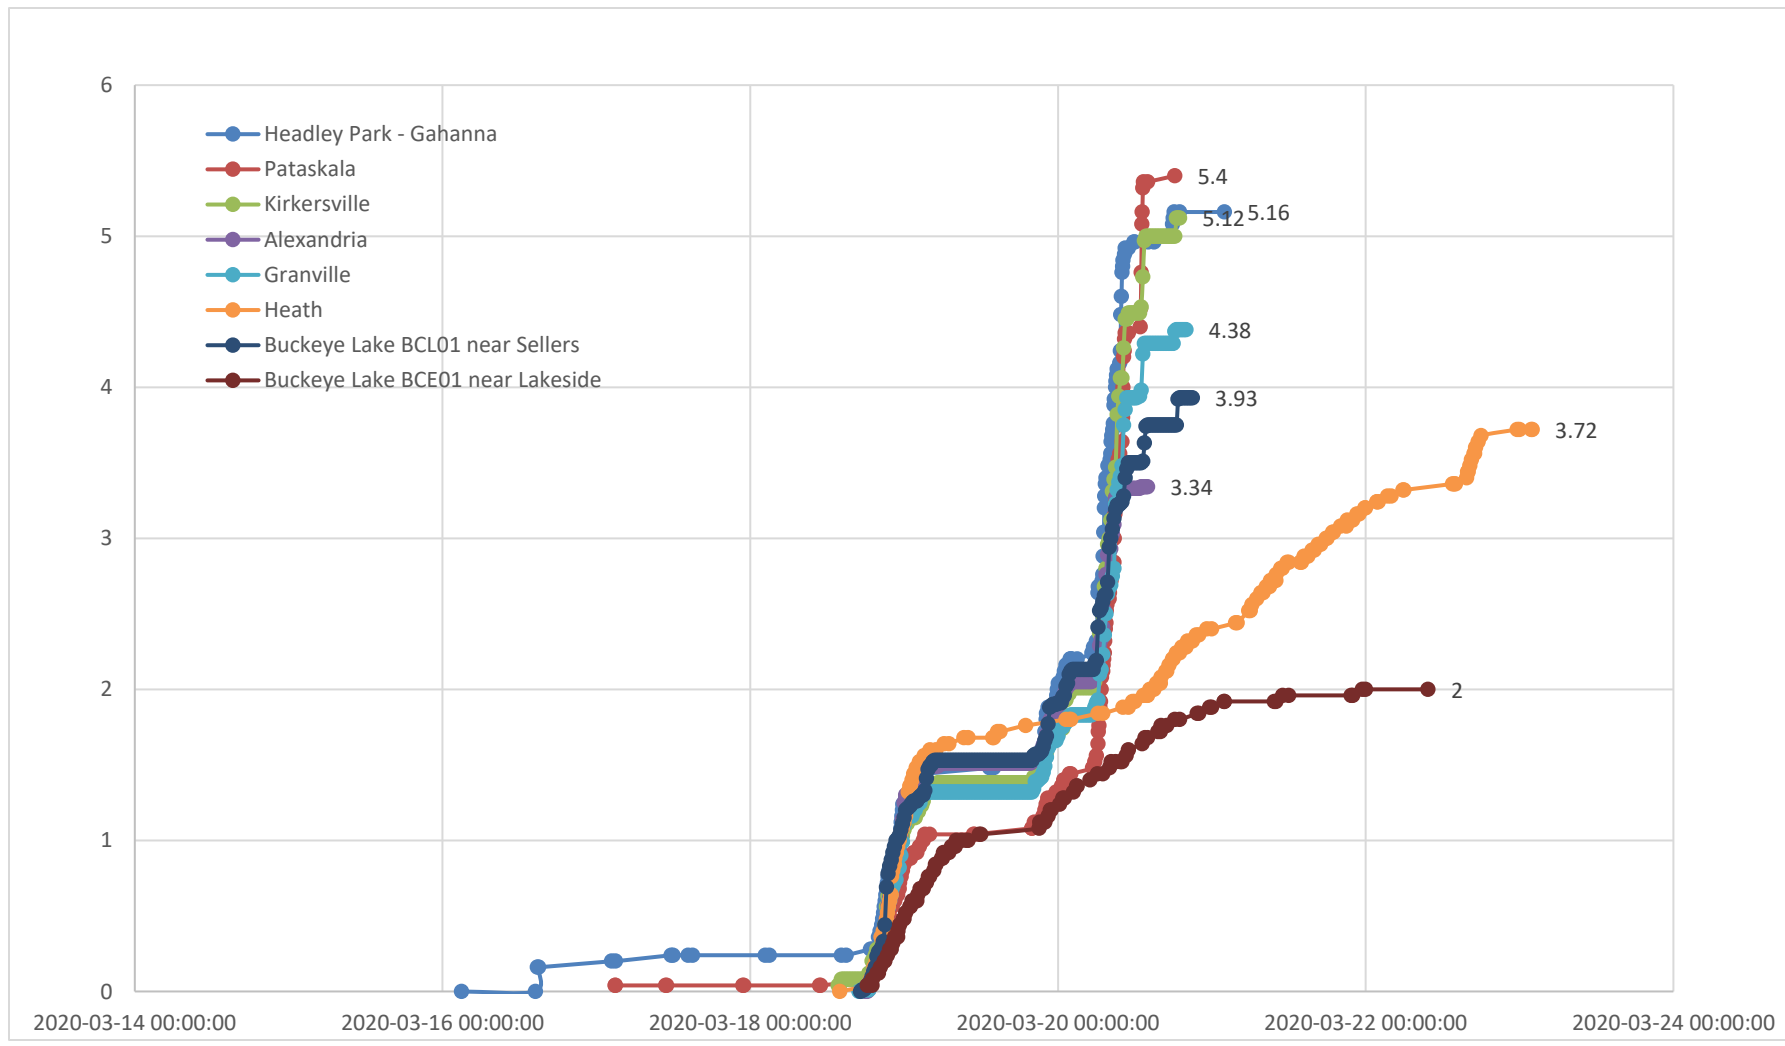
FIGURE 5-13
Summary of Recorded Rainfall Depths (March 2020)

Refer to Figure 5-13 for a graphical summary of the rainfall data gathered from various gauges. The largest rainfall depths were recorded at Headley Park in Gahanna, in Pataskala, and near Kirkersville, all within the upper portion of the SFLR watershed. This figure indicates some rainfall gauges appeared to malfunction and not collect all of the rainfall associated with the event, such as the gauges at Heath and near the Lakeside area of Buckeye Lake. The relatively equivalent recorded rainfall depth at these gauges facilitated the model calibration effort for both portion of the HEC-HMS model of the SFLR watershed to Kirkersville, and the AutoCAD SSA model of the Buckeye Lake watershed. For reference purposes, the recorded rainfall depths from the July 2017 event are provided in Figure 5-14.

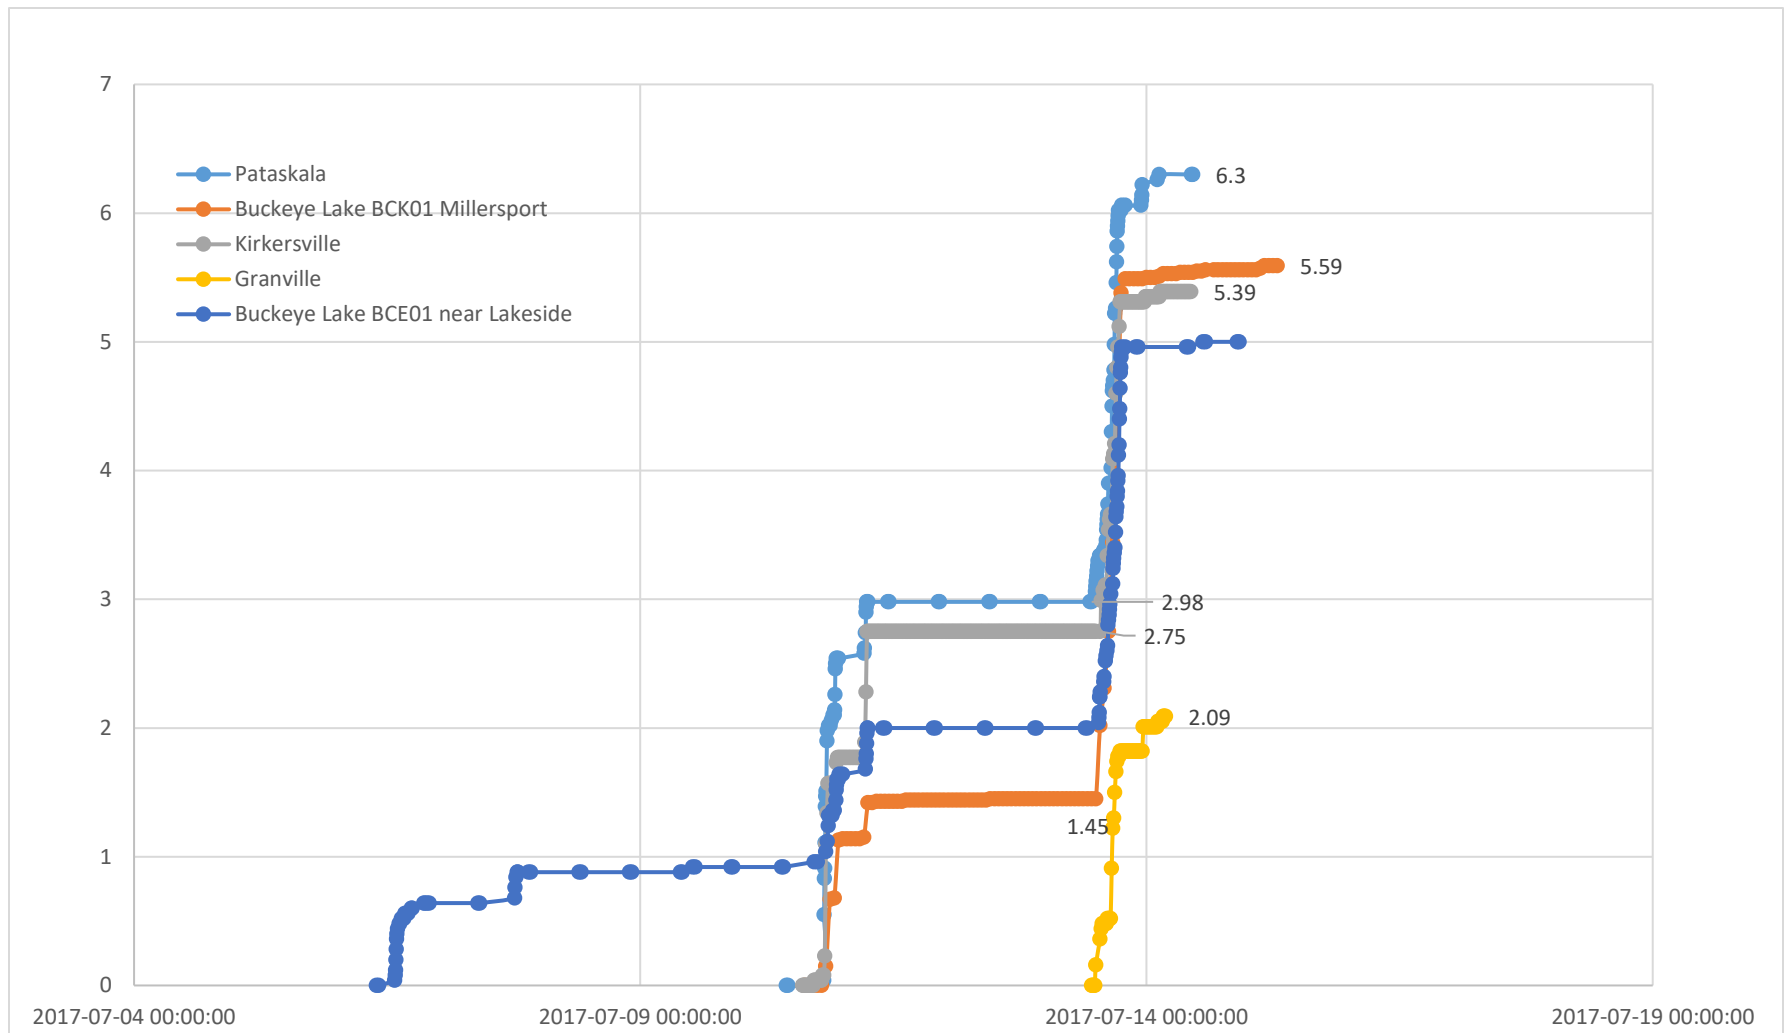
FIGURE 5-14
Summary of Recorded Rainfall Depths (July 2017)

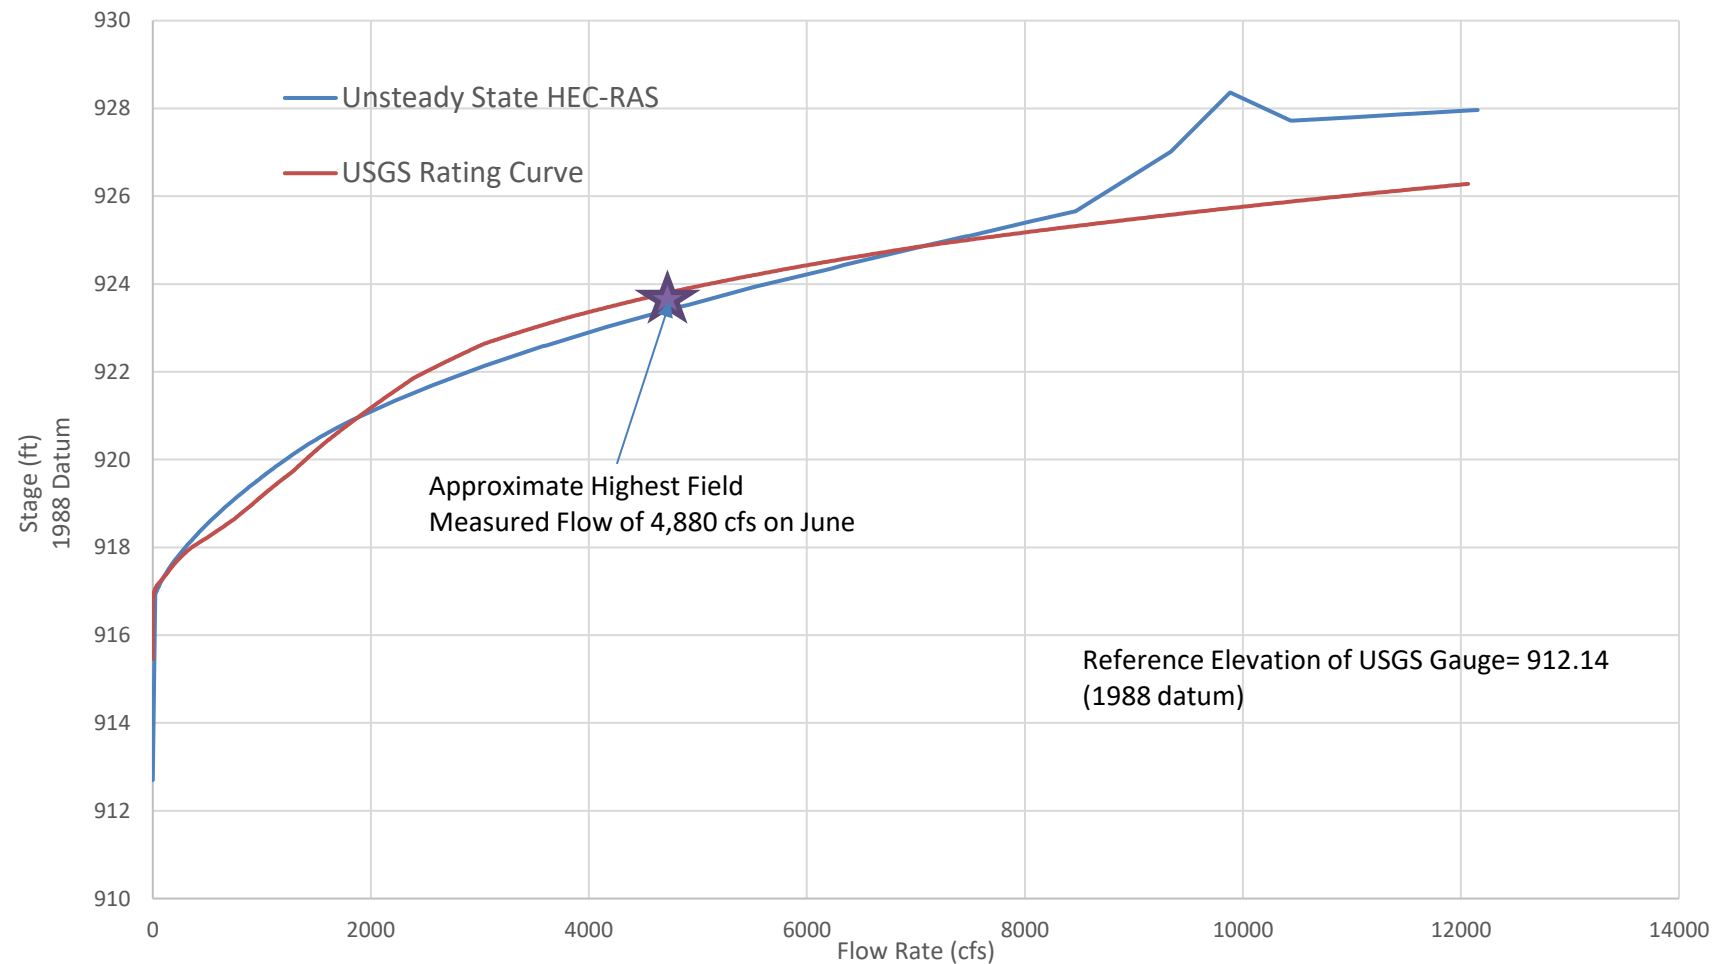
FIGURE 5-16
Flood Elevation Comparison – Calculated vs. Recorded at USGS Kirkersville Stream Gauge (May 2020)

The unsteady-state HEC-RAS model developed by the USGS for the SFLR demonstrates a divergence from the published rating curve at higher peak flood discharge values, as demonstrated on Figure 5-16. The two rating curves in this figure represent the SFLR at the location of the Kirkersville stream gauge. Using the established rating curve at the stream gauge produces a higher peak flood discharge value and flow volume based on the observed gauge reading (flood depth), above 8,000 cfs., compared to using the unsteady-state HEC-RAS model.

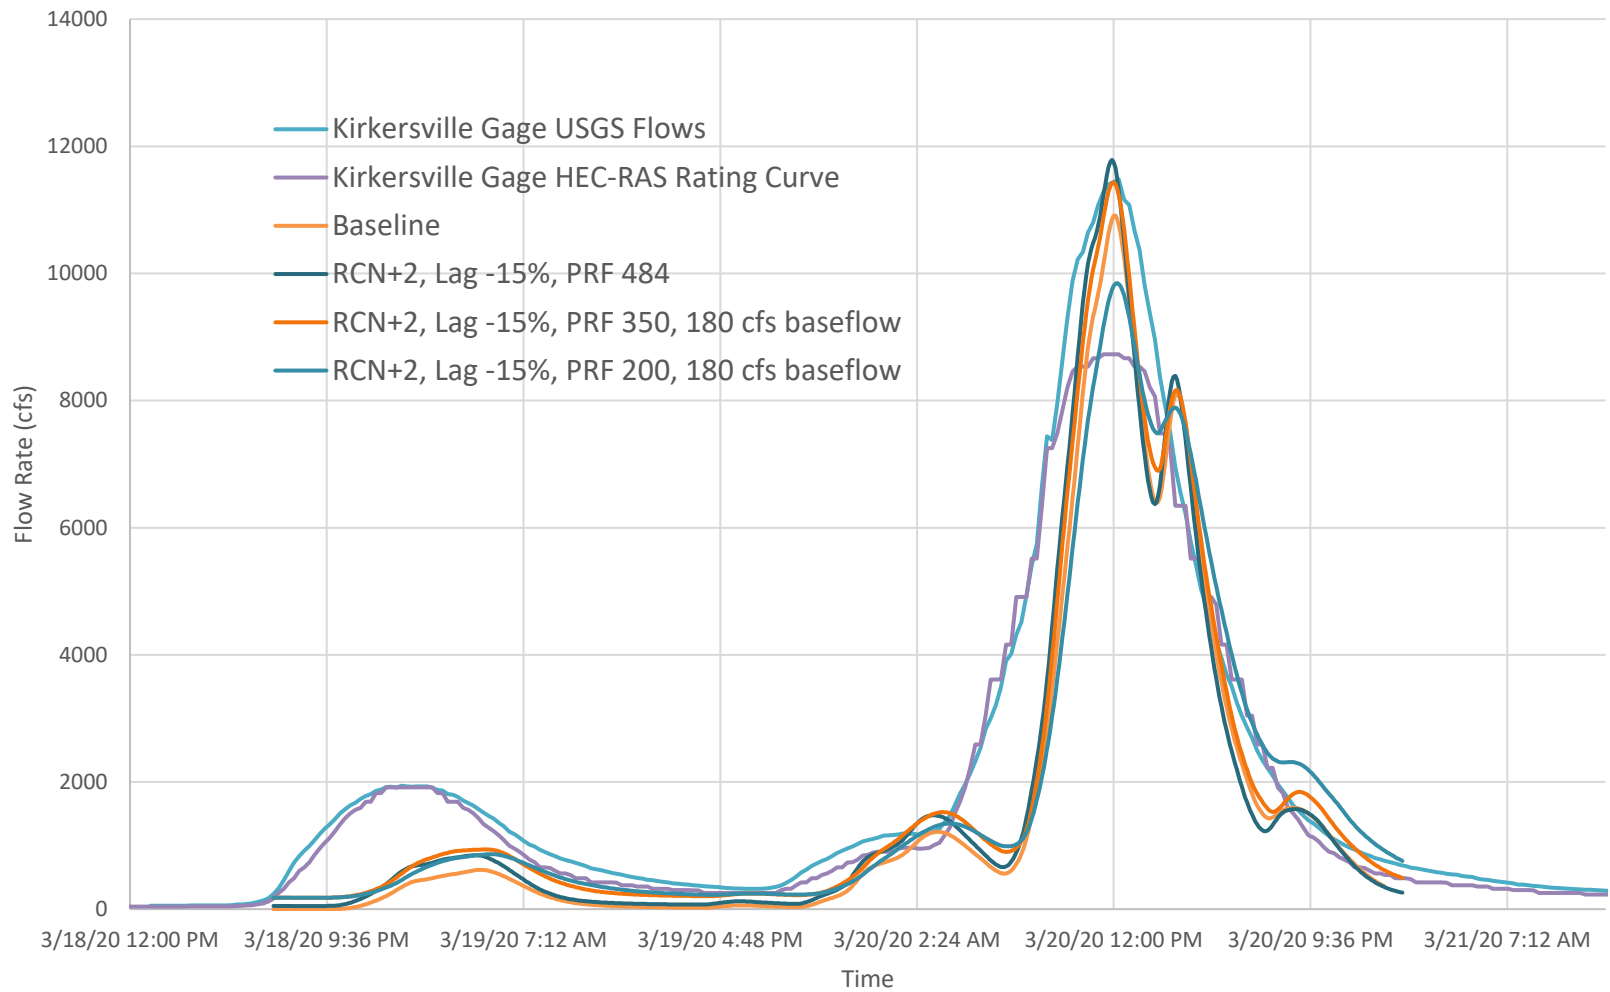
FIGURE 5-17
Flood Elevation Comparison – HEC-HMS Model Calculated vs. Recorded at USGS Kirkersville Stream Gauge (May 2020)

Using a PF value of 200, an RCN of +2, a lag time reduction of 15%, and a baseflow of 180 cfs, yields a March 2020 HEC-HMS peak flow of 9,848 cfs at Kirkersville. In comparison, the estimated peak flood discharge value from the March 2020 event was 8,770. The higher calculated flood discharge value may be conservative, but the calculated flow volume is a very close match to the March 2020 event. A graphical comparison of the HEC-HMS model runs to the recorded flooding from the USGS Kirkersville stream gauge for the March 2020 event is shown on Figure 5-17.

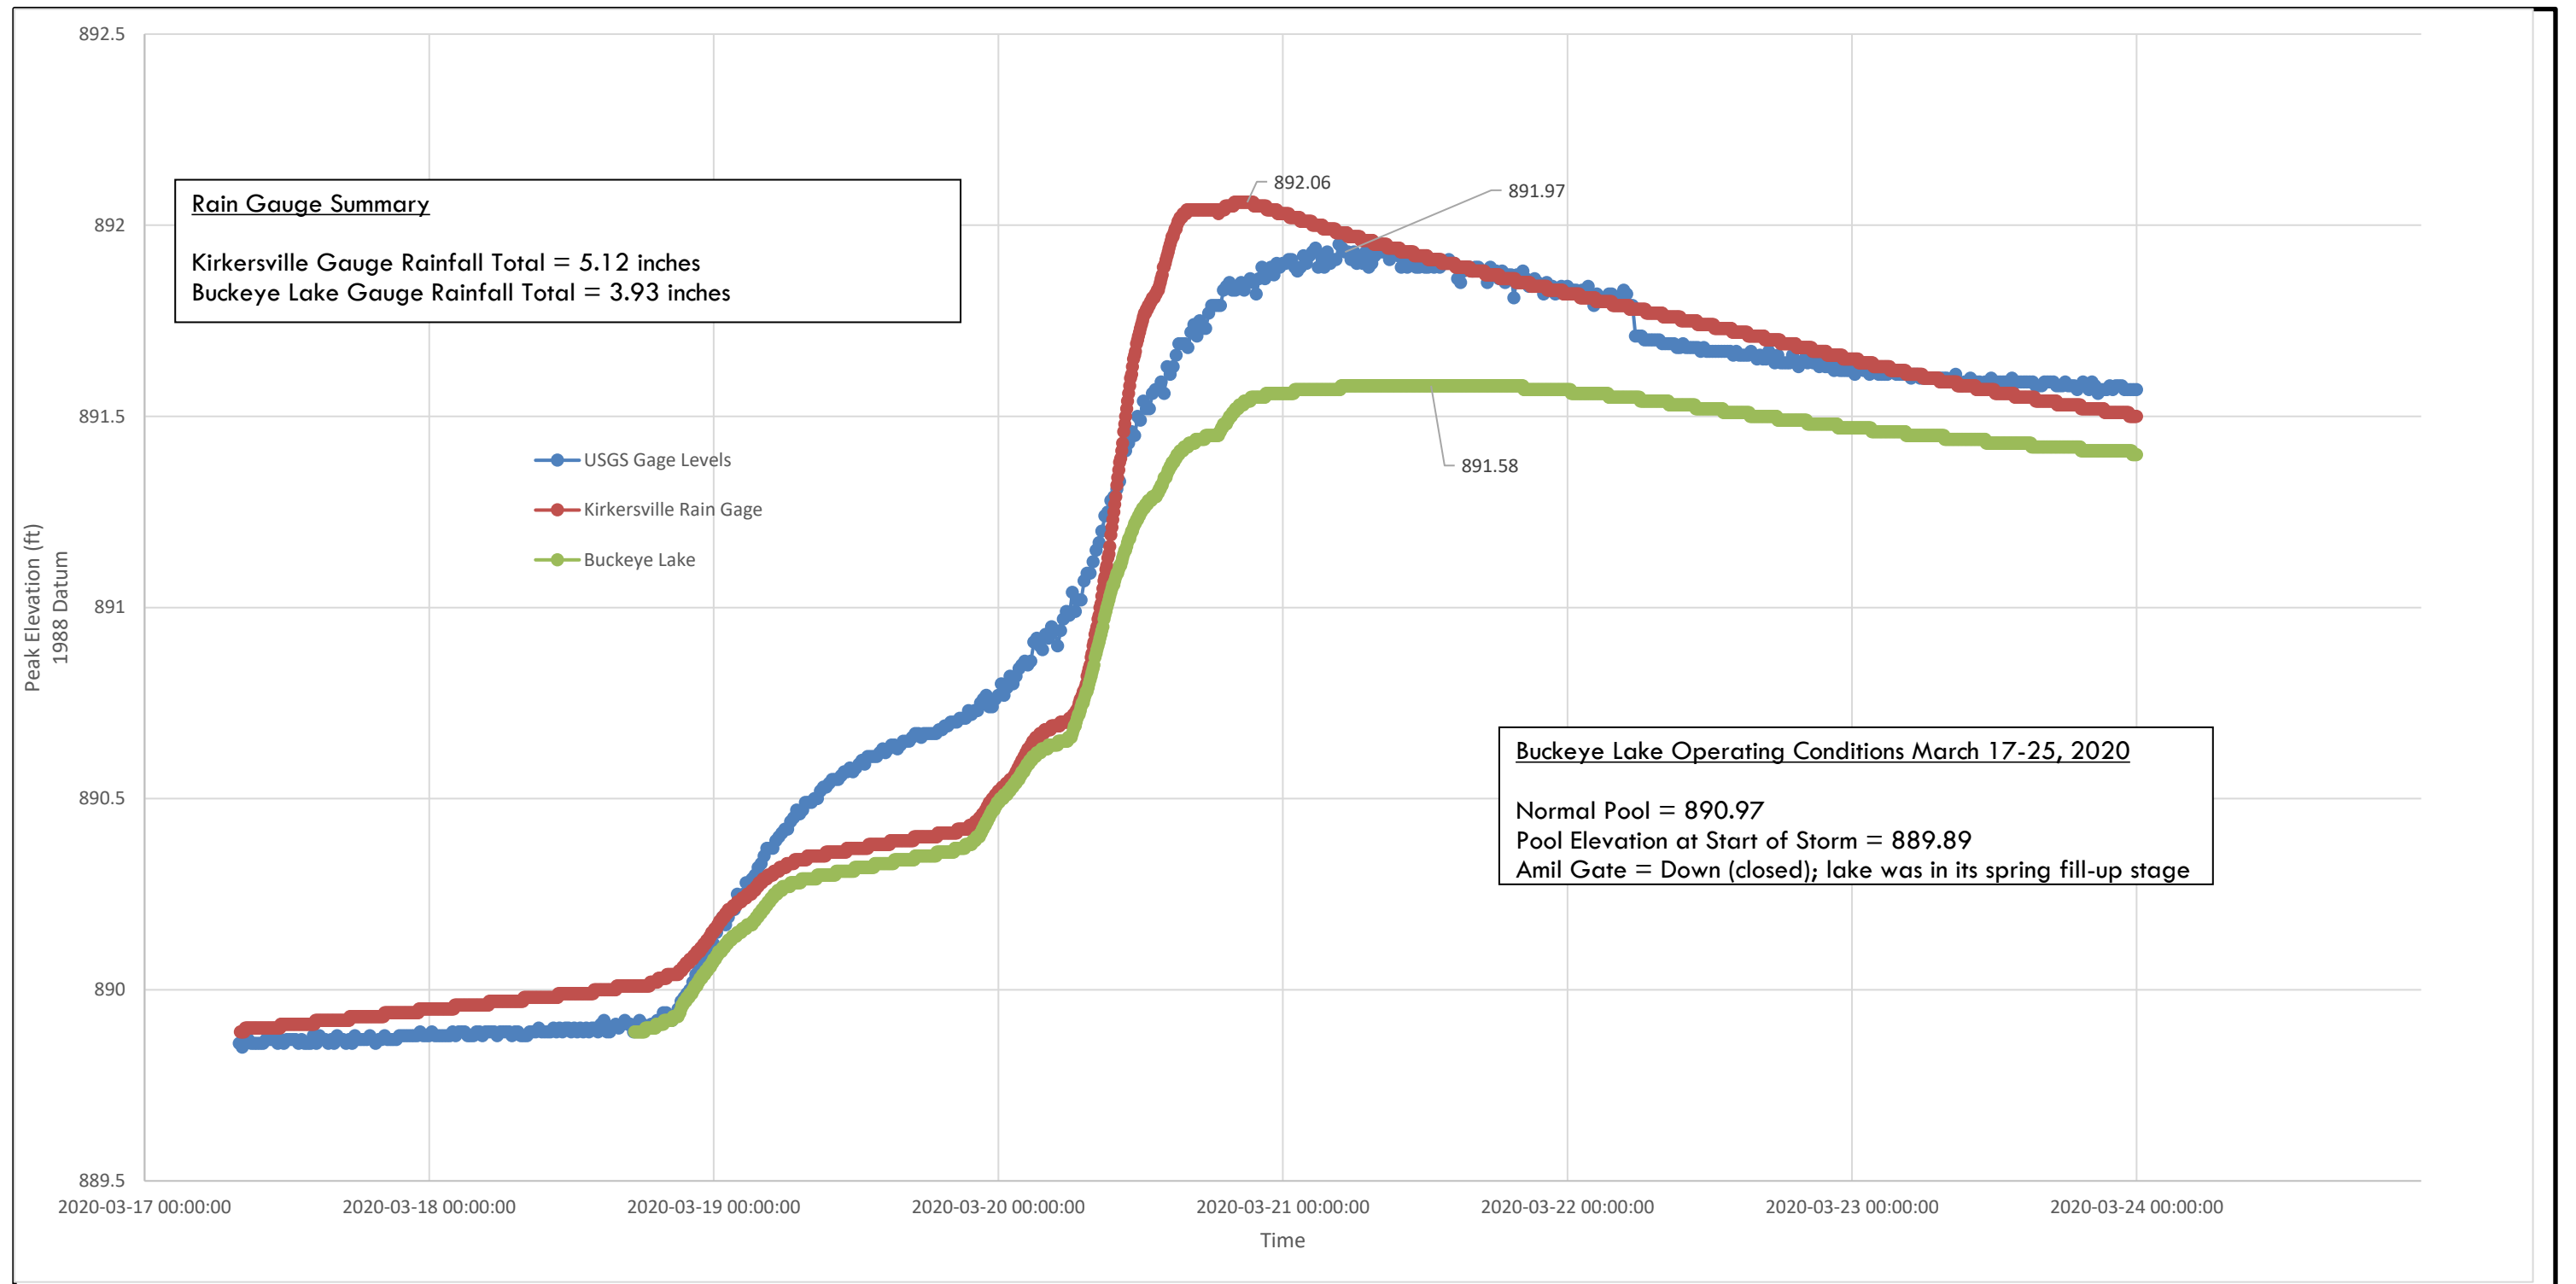
FIGURE 5-19
Buckeye Lake Calculated vs. Recorded Lake Elevations (March 2020)

Figure 5-19 shows the calculated lake elevations vs. the recorded gauge elevations for the March 2020 storm event using two different rain gauges with the preferred calibration parameters of RCN +2 with 120 cfs of baseflow. The SSA model can only model one rainfall data set at a time; therefore, separate model runs were executed for the recorded rainfall data at the USGS Kirkersville gauge and at the Buckeye Lake gauge. Both model results are shown on Figure 5-19. The SSA model using the recorded rainfall data from the USGS Kirkersville gauge (total = 5.12 inches) estimated a maximum lake elevation 0.09 feet higher than the recorded elevation.

The model using the recorded rainfall data at the Buckeye Lake gauge estimated a maximum lake elevation 0.39 feet lower than the recorded elevation. This is a reasonable outcome given the likelihood the Feeder Canal and northern lake drainage areas received the higher rainfall amount recorded at Kirkersville, while portions of the lake and southern watershed area likely received the lower rainfall amount. A rainfall data synthesized from the two rain gauges would have likely resulted in a closer calibration to the recorded lake elevations.

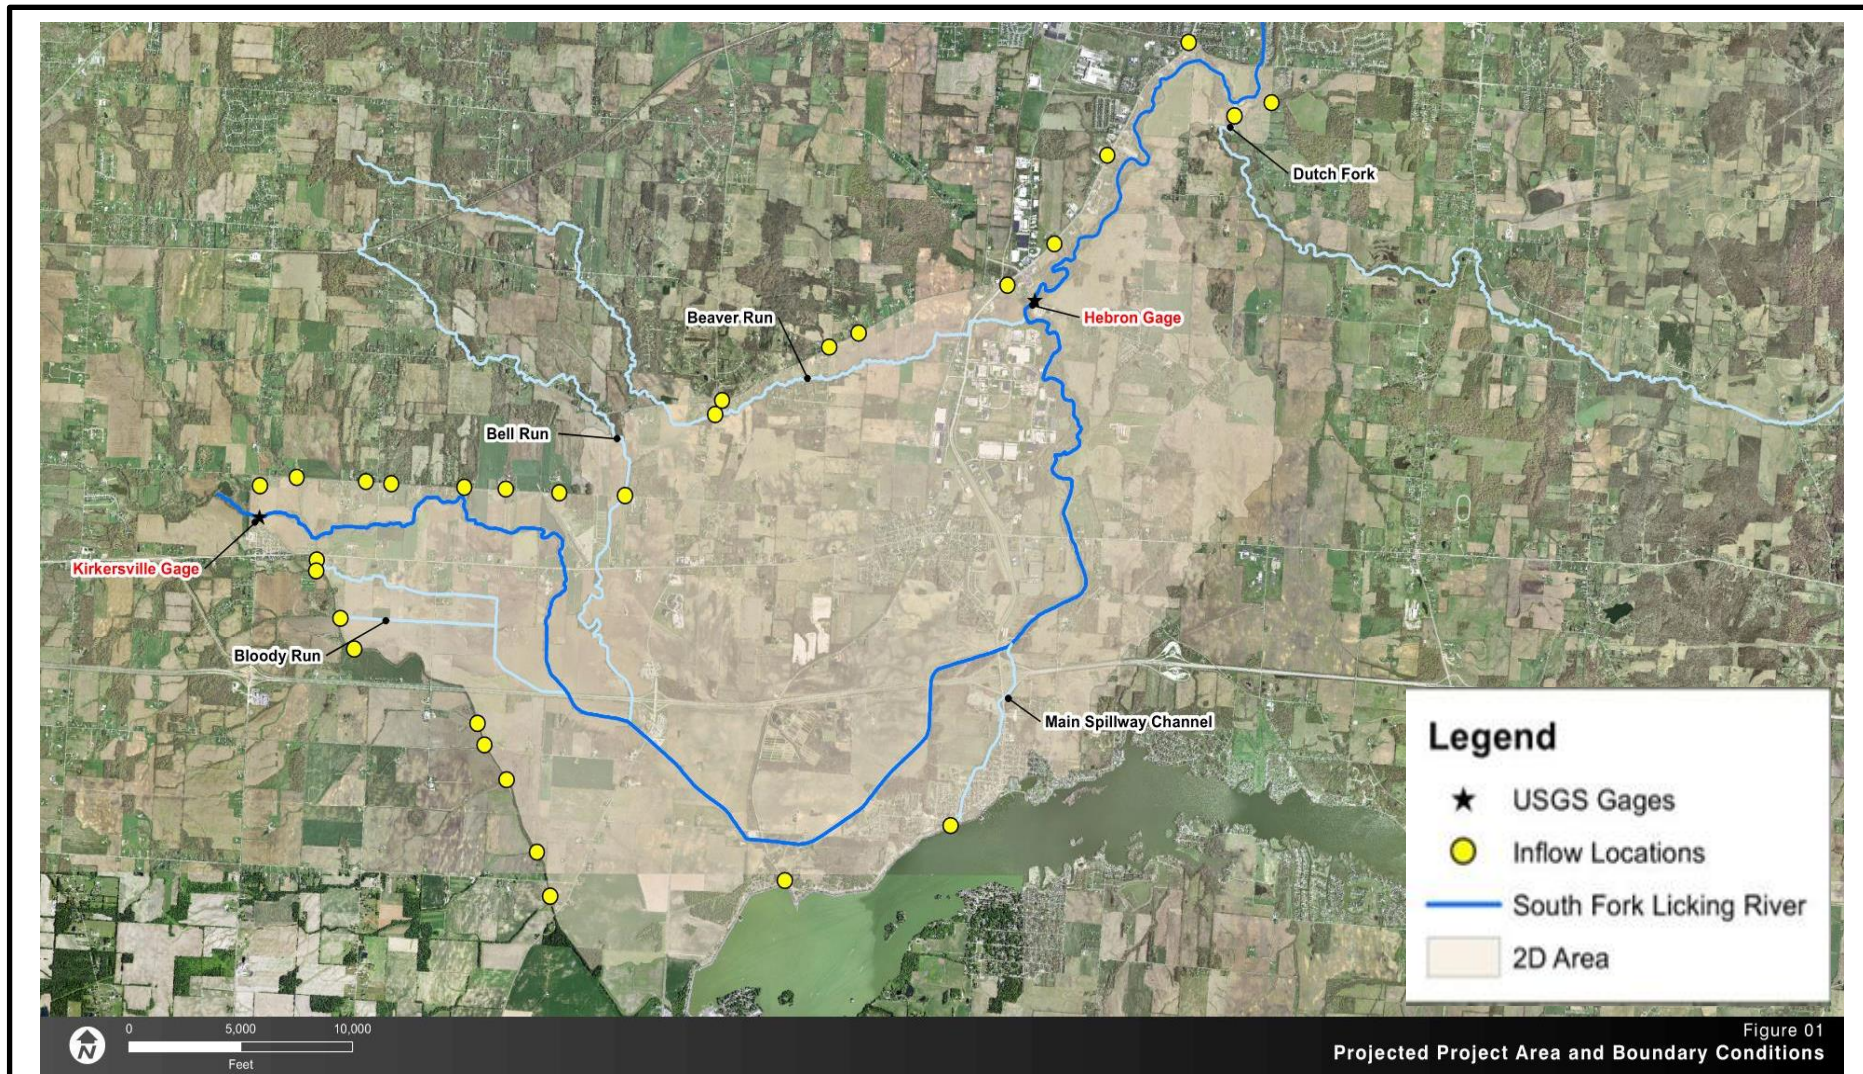
Figure 01
Projected Project Area and Boundary Conditions

FIGURE 6-3
Watershed Interface Points between HEC-HMS and 2D HEC-RAS Models
 (Image prepared by ms consultants)

The results of the HEC-HMS models with the seven dry dams were transferred and integrated into the 2D HEC-RAS to determine the benefits in terms of reducing calculated flood elevations and the correlating extent of the floodplain. Only the 100-year design model results were considered for this purpose. Hydrographs from the HEC-HMS model were used as input to the 2D HEC-RAS model at numerous locations along the watershed interface with the 2D model area, as described in the report prepared by ms consultants referenced previously, and shown on Figure 6-3.

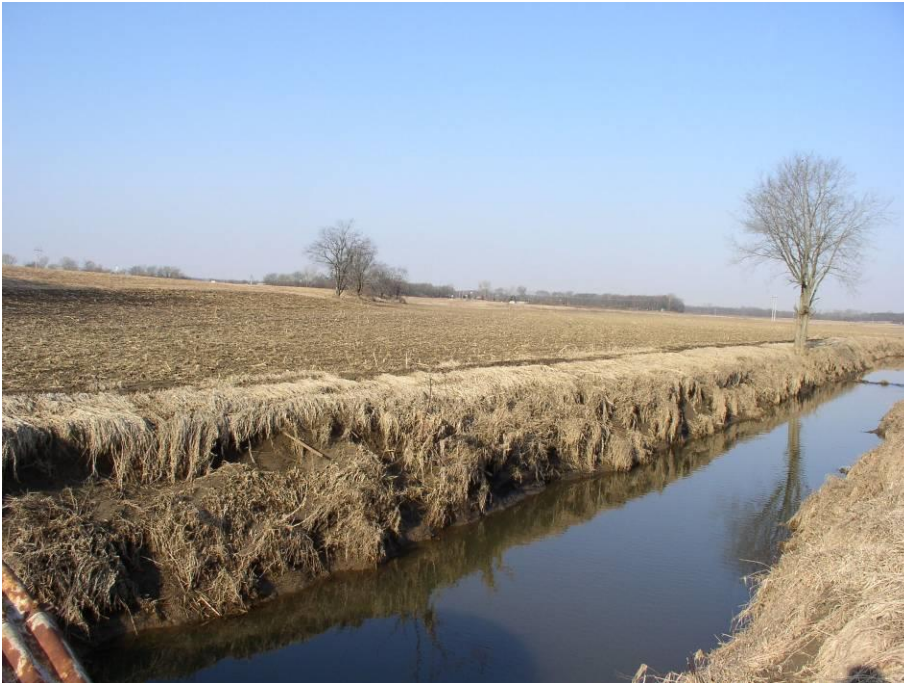
Figure 1: Banks of Pigeon Swamp Ditch Located within the proposed flood pool.

The failure along the banks of Pigeon Swamp Ditch and its tributaries is shown in Figures 1 and 2. Failure of these banks is slow in nature and does not constitute a major problem along the streams today. However, over time Pigeon Swamp Ditch and its tributaries are widening as a result of the progressive sapping failure of the banks. In the 1950s Pigeon Run Ditch was improved. The engineering drawings show a top width of 40 feet. Today, the top width in many places is 60 feet and more. Over time, Pigeon Swamp Ditch will continue to widen at an average annual rate of about 3 feet per year.

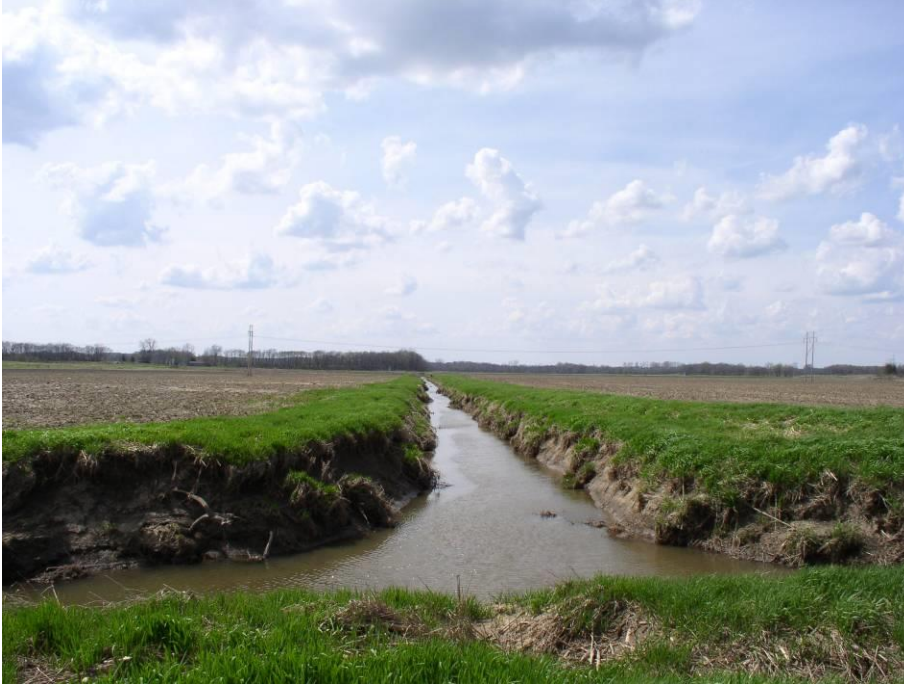
Figure 2 Looking west up a tributary of Pigeon Swamp Ditch. Bank failure caused by sapping occurs along the entire reach.

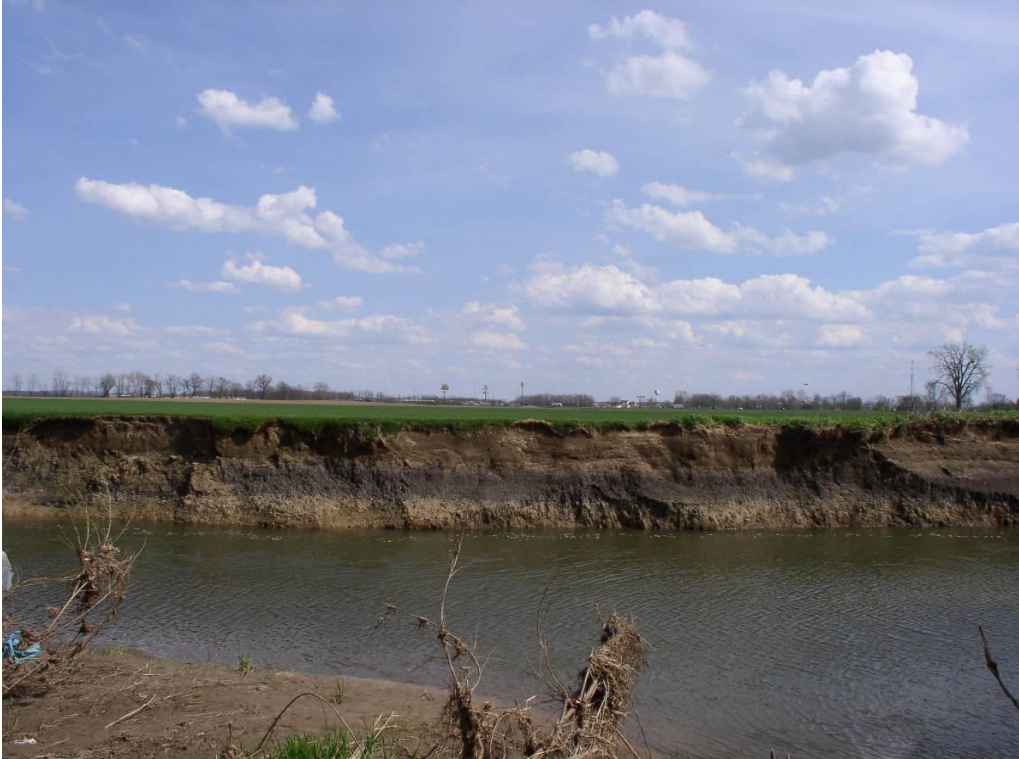
Figure 3 Licking River bank failure in the flood pool

Figures 3 through 6 show areas where the Licking River is very actively eroding its banks in the proposed structure flood pool.

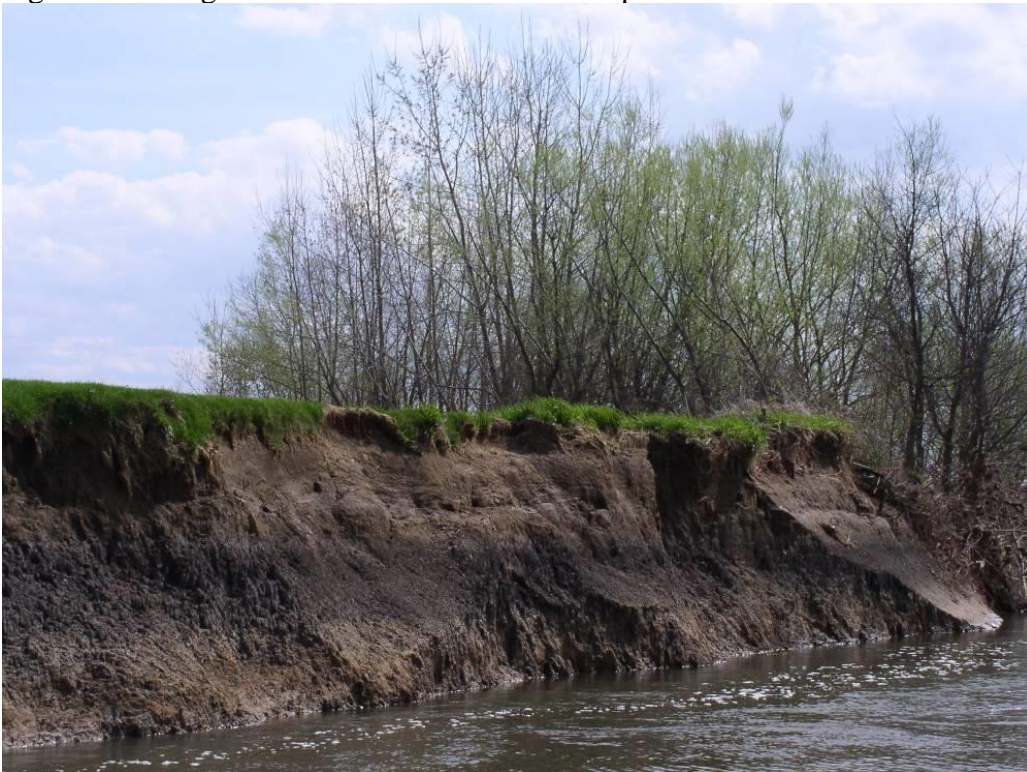
Figure 4 Licking River in the flood pool

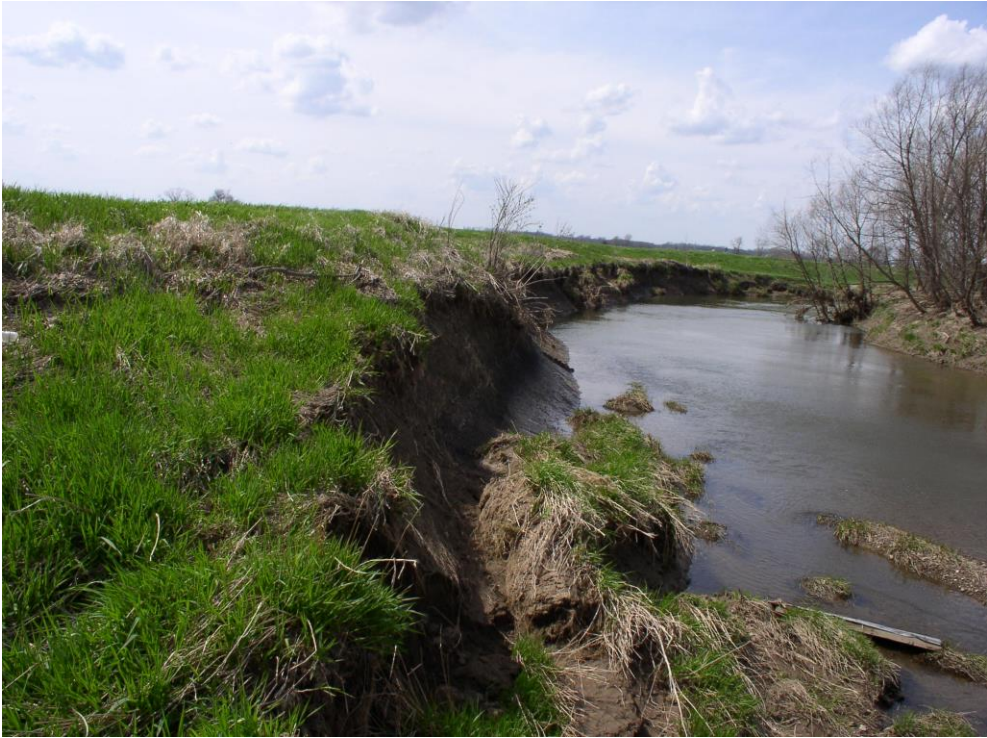
Figure5 Bank failure along the Licking River in the flood pool. Blocks breaking
Away from the banks with their tops tilted toward the river. In this case the river took
about 2 feet of bank or more over the length of the meander in one event.

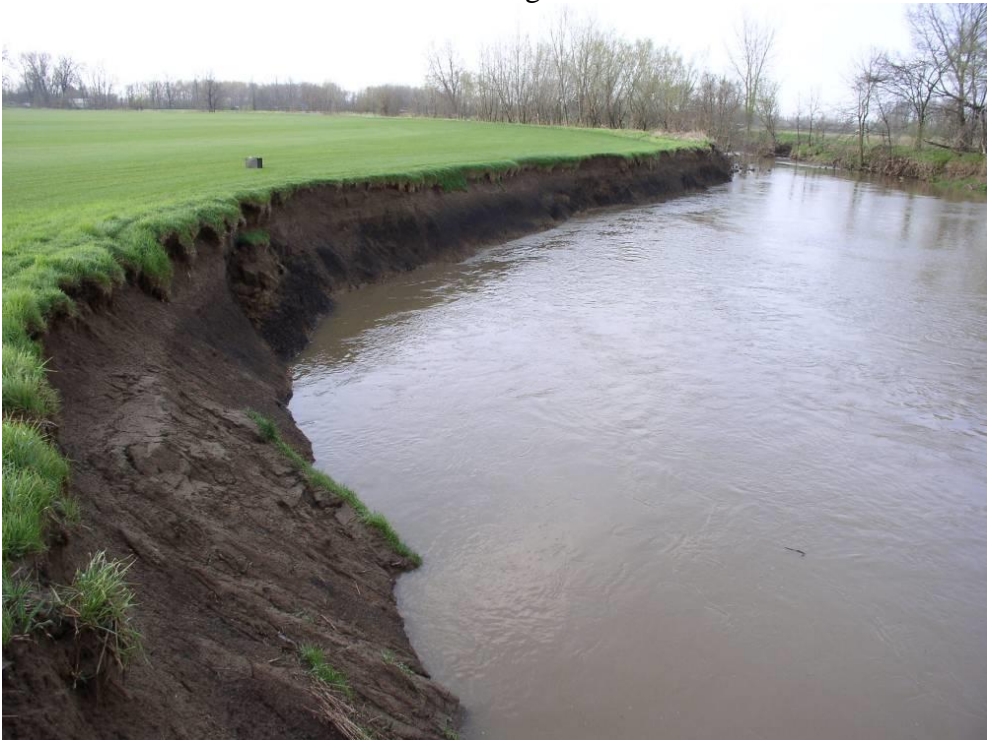
Figure 6. Dramatic bank failure along the Licking River in the proposed flood pool.

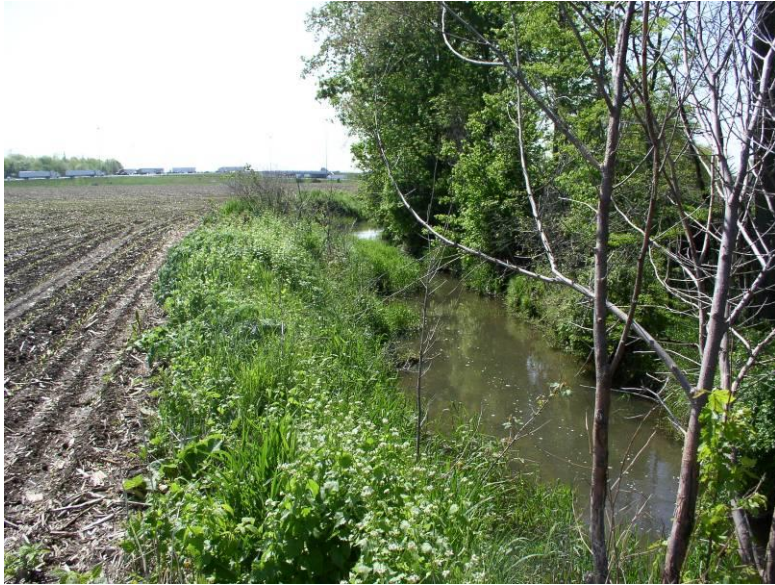
Figure7. Bell Run near location where it will be crossed by the proposed dam and channel.

Bell run is a stream located about 3000 feet east of the Licking River and flows in a north to south direction parallel to the river. The stream meanders considerably through the area within the proposed flood pool. The banks of Bell run appear to be stable and the channel is a more typical trapezoidal shape. Bell Run is not experiencing the same kind of erosion as Pigeon Swamp Ditch and the Licking River.

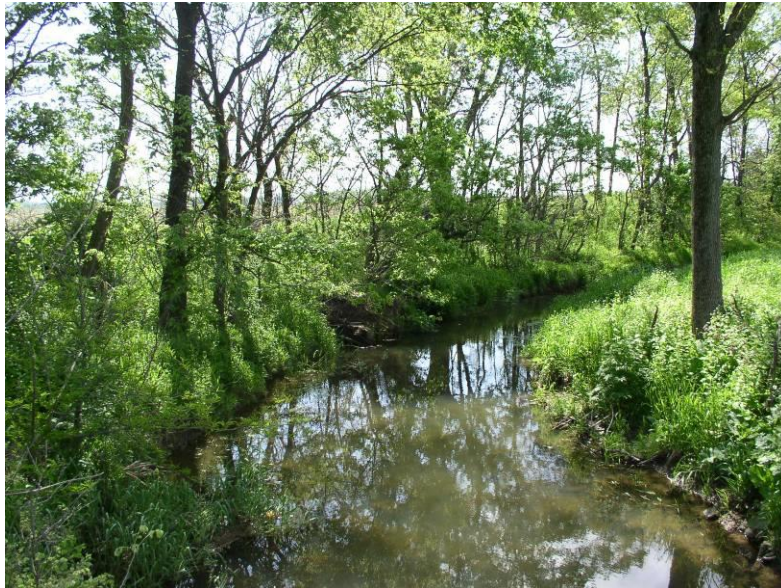
Figure 8 stable banks of bell Run

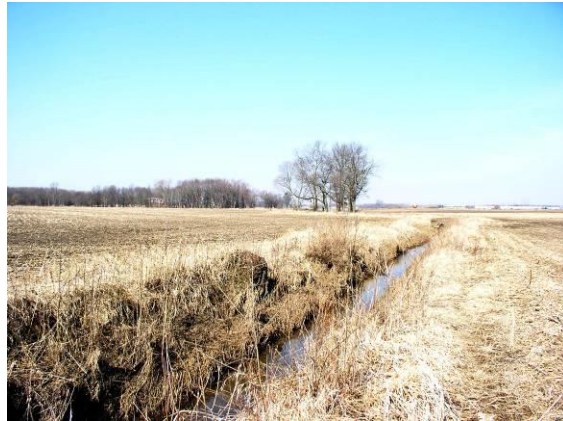
Kuhn Ditch is farther east of the river and is outside of the proposed dam. The ditch has a drainage area of about a thousand acres and crosses the proposed flood by-pass channel about 2 miles east of the proposed dam. Kuhn Ditch has very stable banks and a typical trapezoidal shaped channel.

Figure 9. Stable banks along Kuhn ditch.

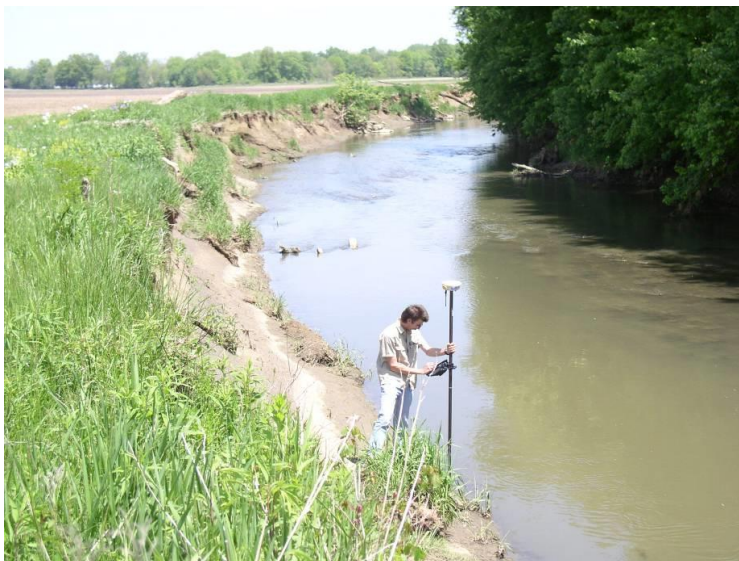
The proposed flood by-pass channel will outlet back into the Licking River about 3 miles east of its origin. The river banks close to the outlet seem to be experiencing the same kind of failure at this point as they are upstream in the proposed flood pool. The banks on the west side of the river are failing and sliding down into the river.

Figure 10. The Licking River near the outlet of the flood by-pass channel.

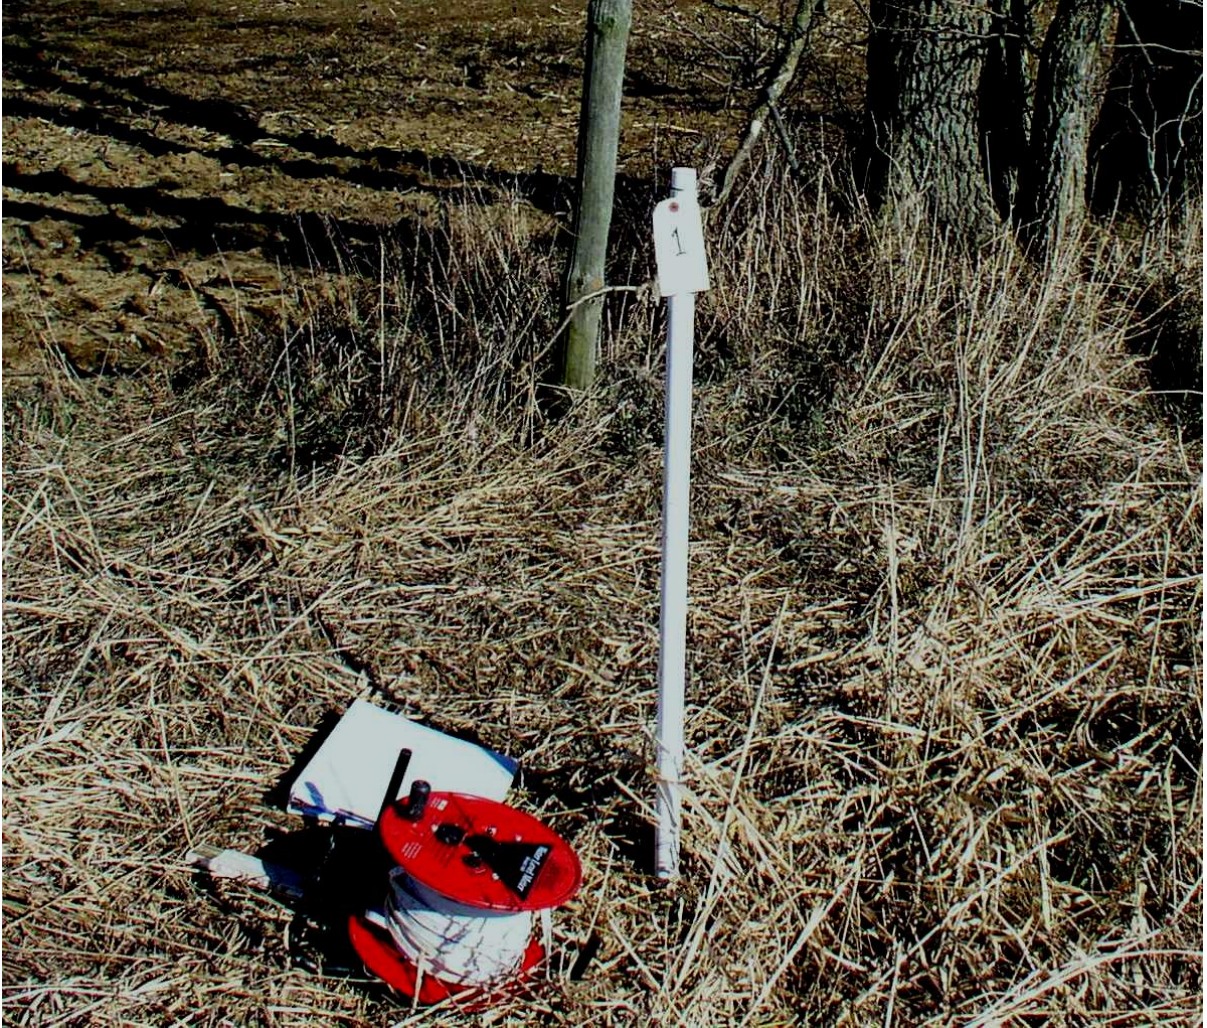
Figure A typical piezometer installation with electric water level measuring tape.

The ground water study also involved the installing of about 20 observation wells. The water levels in these wells are recorded monthly with the use of an electric water level tape. Piezometric surface maps were generated in order to predict the depth of ground water during channel construction. Figure is a photograph of the installed Piezometer 1 with the electric tape used for monitoring water levels. Figure is a map of the piezometer locations.
