SOUTH FORK LICKING RIVER

Flood Damage Reduction Planning Study

Prepared for:

South Licking Watershed Conservancy District

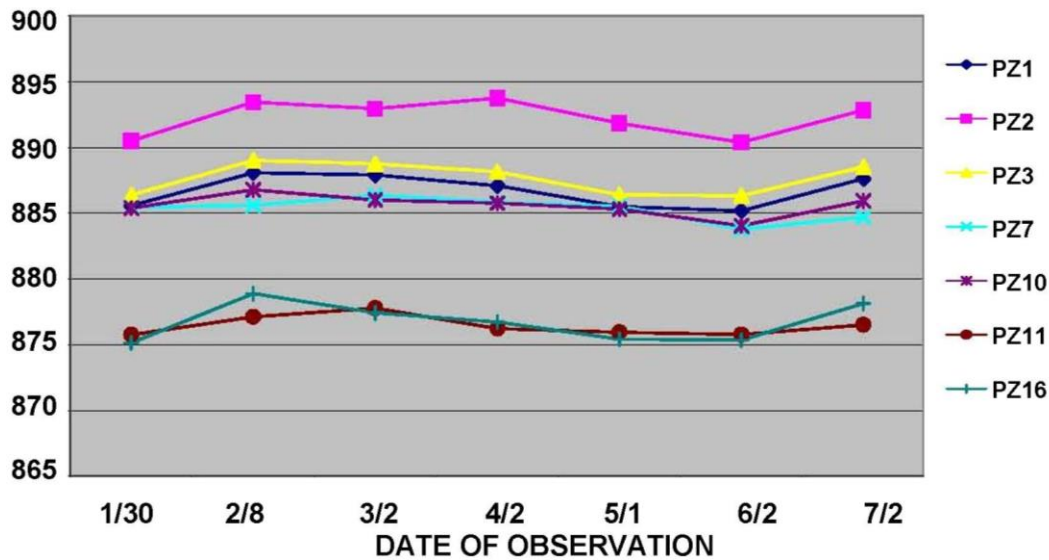
WATER LEVELS IN THE SEVEN PIEZEMOTERS NEAREST THE BY-PASS CHANNEL

Figure Similar hydrographs of the seven closest piezometers to the flood by-pass channel.

The piezometer study demonstrated that all of the shallow ground water in the area is connected and responds directly to rainfall and the rise and fall of the Licking River. Figure is the long term hydrograph of the seven wells that are closest to the flood by-pass channel. They like the rest of the piezometers installed in the sand and gravel deposits behave very similar to one another.

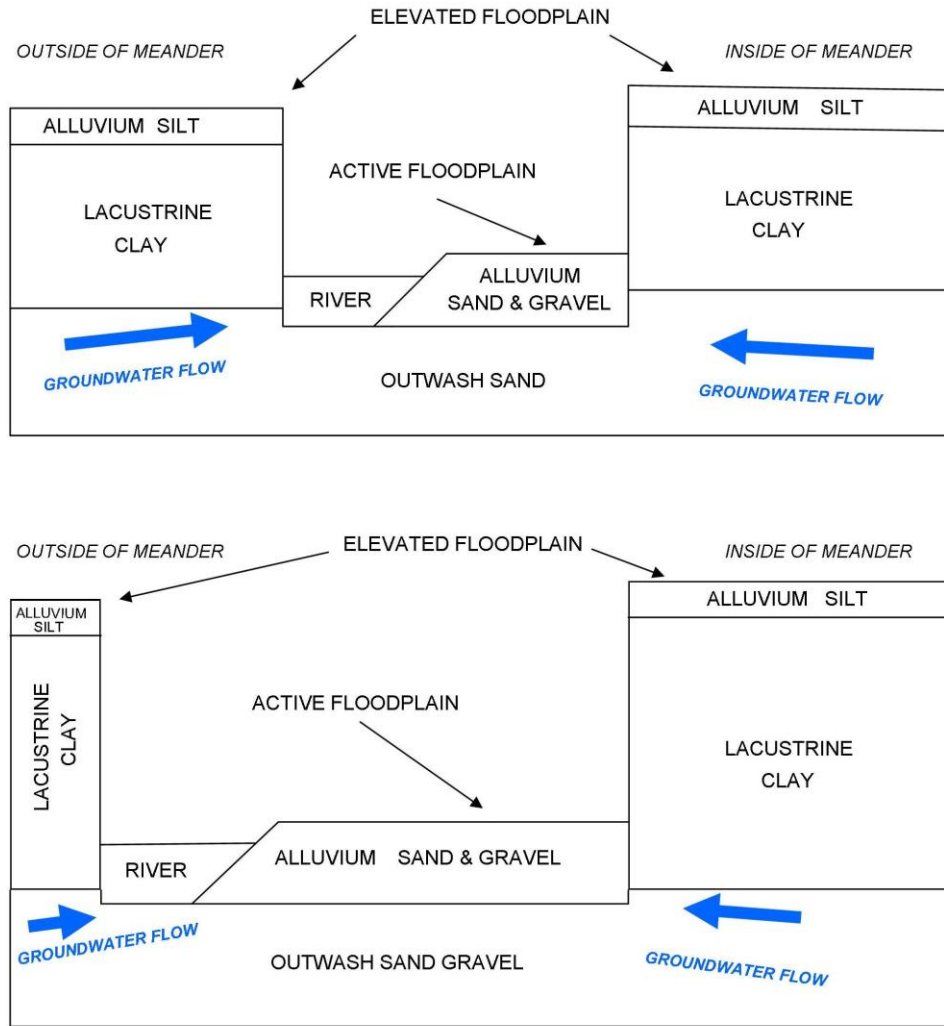
LICKING RIVER FLOOD PLAIN LEVELS AND STREAMBANK EROSION

Figure 13 a schematic of the geologic materials and their relative positions along the Licking River in the pool area above the dry dam. The thickness of the lacustrine deposits is eight to ten feet and the width of the river and its active floodplain is between 80 and 160 feet.

The blue arrows in figure 13 show the direction of ground water flow into the river. The groundwater in the sand and gravel is under artesian pressures.

During the geologic exploration of the area much was learned about the unstable banks on the Licking River and. Figure 13 is diagram that correctly describes what is happening in the Licking River floodplain in the pool area above the dry dam and to a lesser extent along the area of the bypass channel outlet.

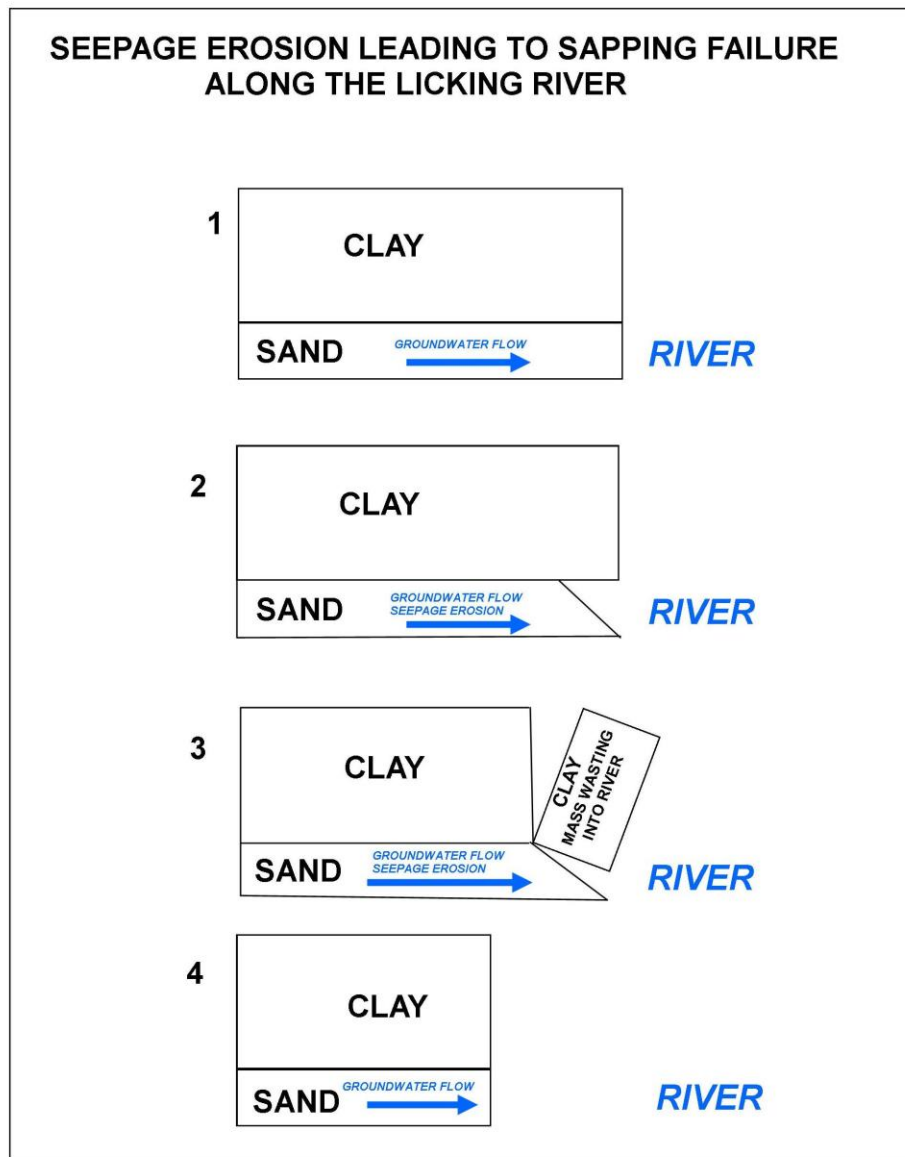
Figure 14 Seepage erosion .leading to sapping failure.

The erosion of these banks is accelerated by the sapping process. The process starts with groundwater moving through the sand which leads to seepage erosion. As the sand erodes the much stronger clay is undermined. With its support removed, the clay will fail and large blocks will be mass wasted into the river. Once in the river the clay is suspended in

the river water and carried away very easily. This process is happening continually on the outsides of the meanders in the Licking River in the proposed location for the dam, weir and the by-pass channel head. Figure 14 shows this process in detail.

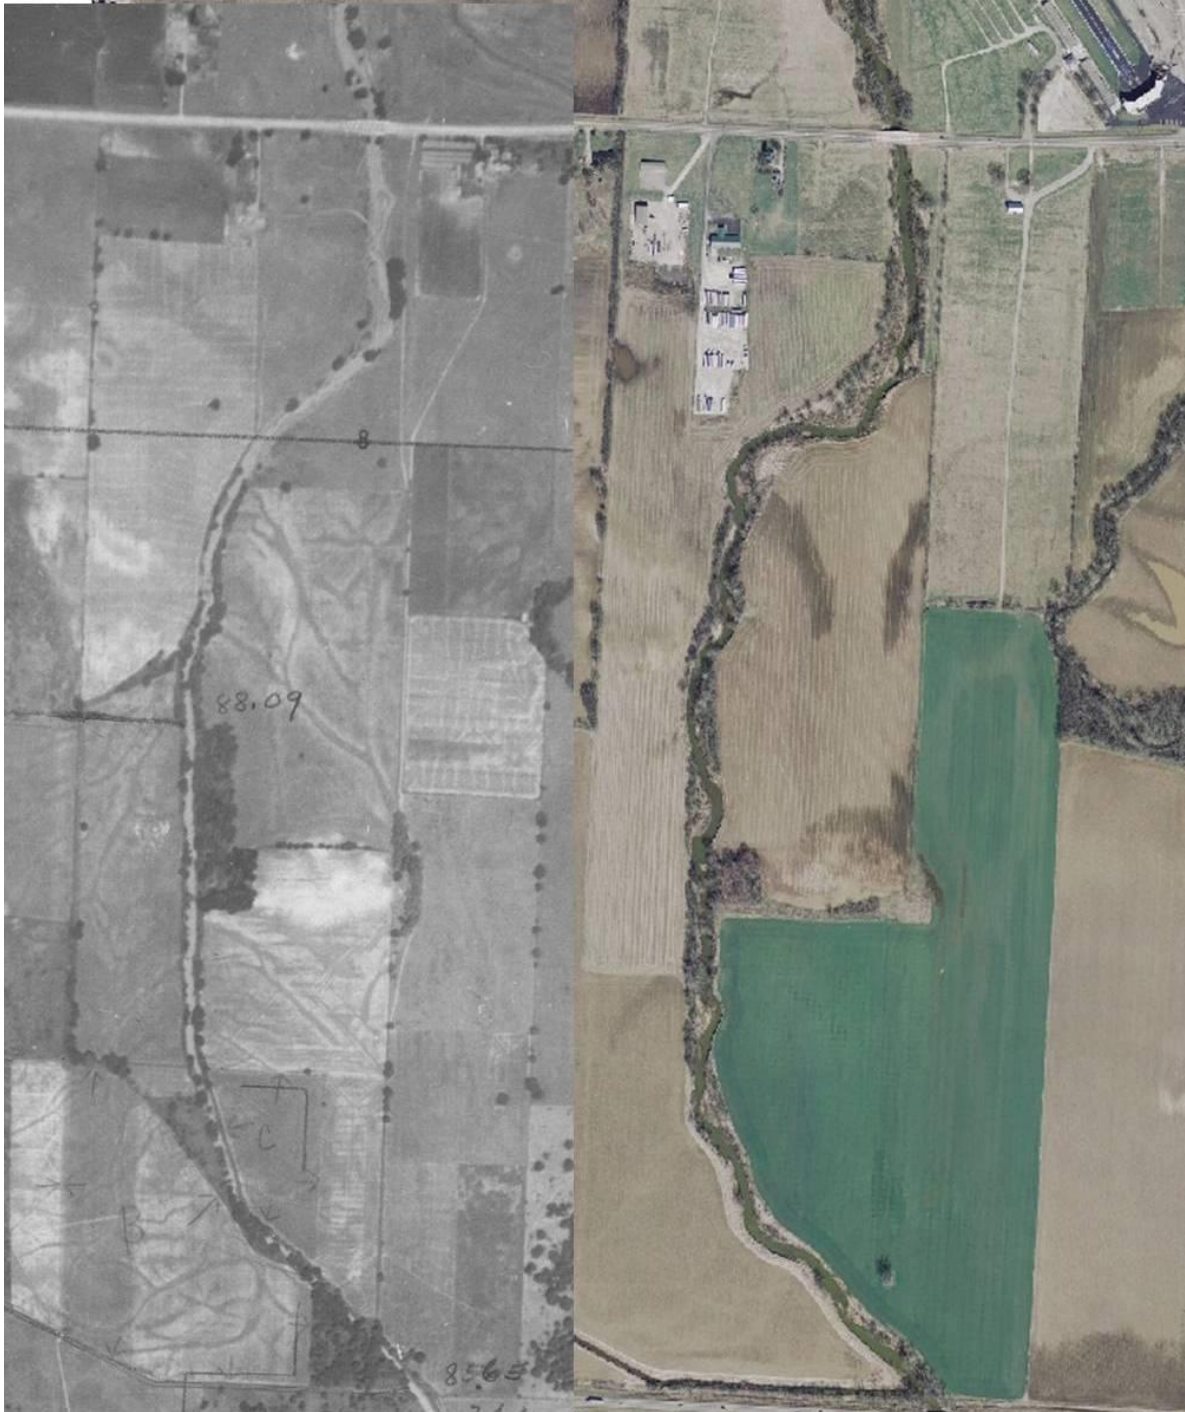
Figure 17 The Licking River in the proposed area in 1930 compared to 2006.

Figure 17 compares a historic 1930 photo on the right with a 2006 photo of the Licking River as it flows through the area of the planned structures. It took 75 years for an artificial straight drainage ditch that was less than 40 feet wide to transform itself into a meandering river with a valley that is over 150 feet wide. Many of the early years were used by the river to down cut to its current level. Since the time the river has begun to cut out its sides. According to stream mechanics principles, the processes of this river formation are in the early stages. It took 75 years for the river to assume its current sinuous shape. Now that the meanders have clearly formed, the affects of the meanders will greatly accelerate the erosion along the banks. These meanders have greatly enhanced the river's ability to cut into the very erodible banks and create drastic results in the area during the next 100 years. The valley widened about 100 feet in 75 years. It would not be unreasonable to predict another 300 feet or more of valley widening during the life of the project. This amount of future widening is unknown of course. But it is clear that the acceleration of this process will not stop. The river now has perfect conditions to gobble up large areas of the surrounding broad lake plain very quickly.
